COMPREHENSIVE CONDITION SURVEY

✓
Inner Breakwater and the Sand Barrier
Crescent City Harbor
Del Norte County, California

COMPREHENSIVE CONDITION SURVEY OF
CRESCENT CITY HARBOR INNER BRAKWATER AND
SAND BARRIER

Prepared by
U.S. Army Corps of Engineers
Los Angeles District

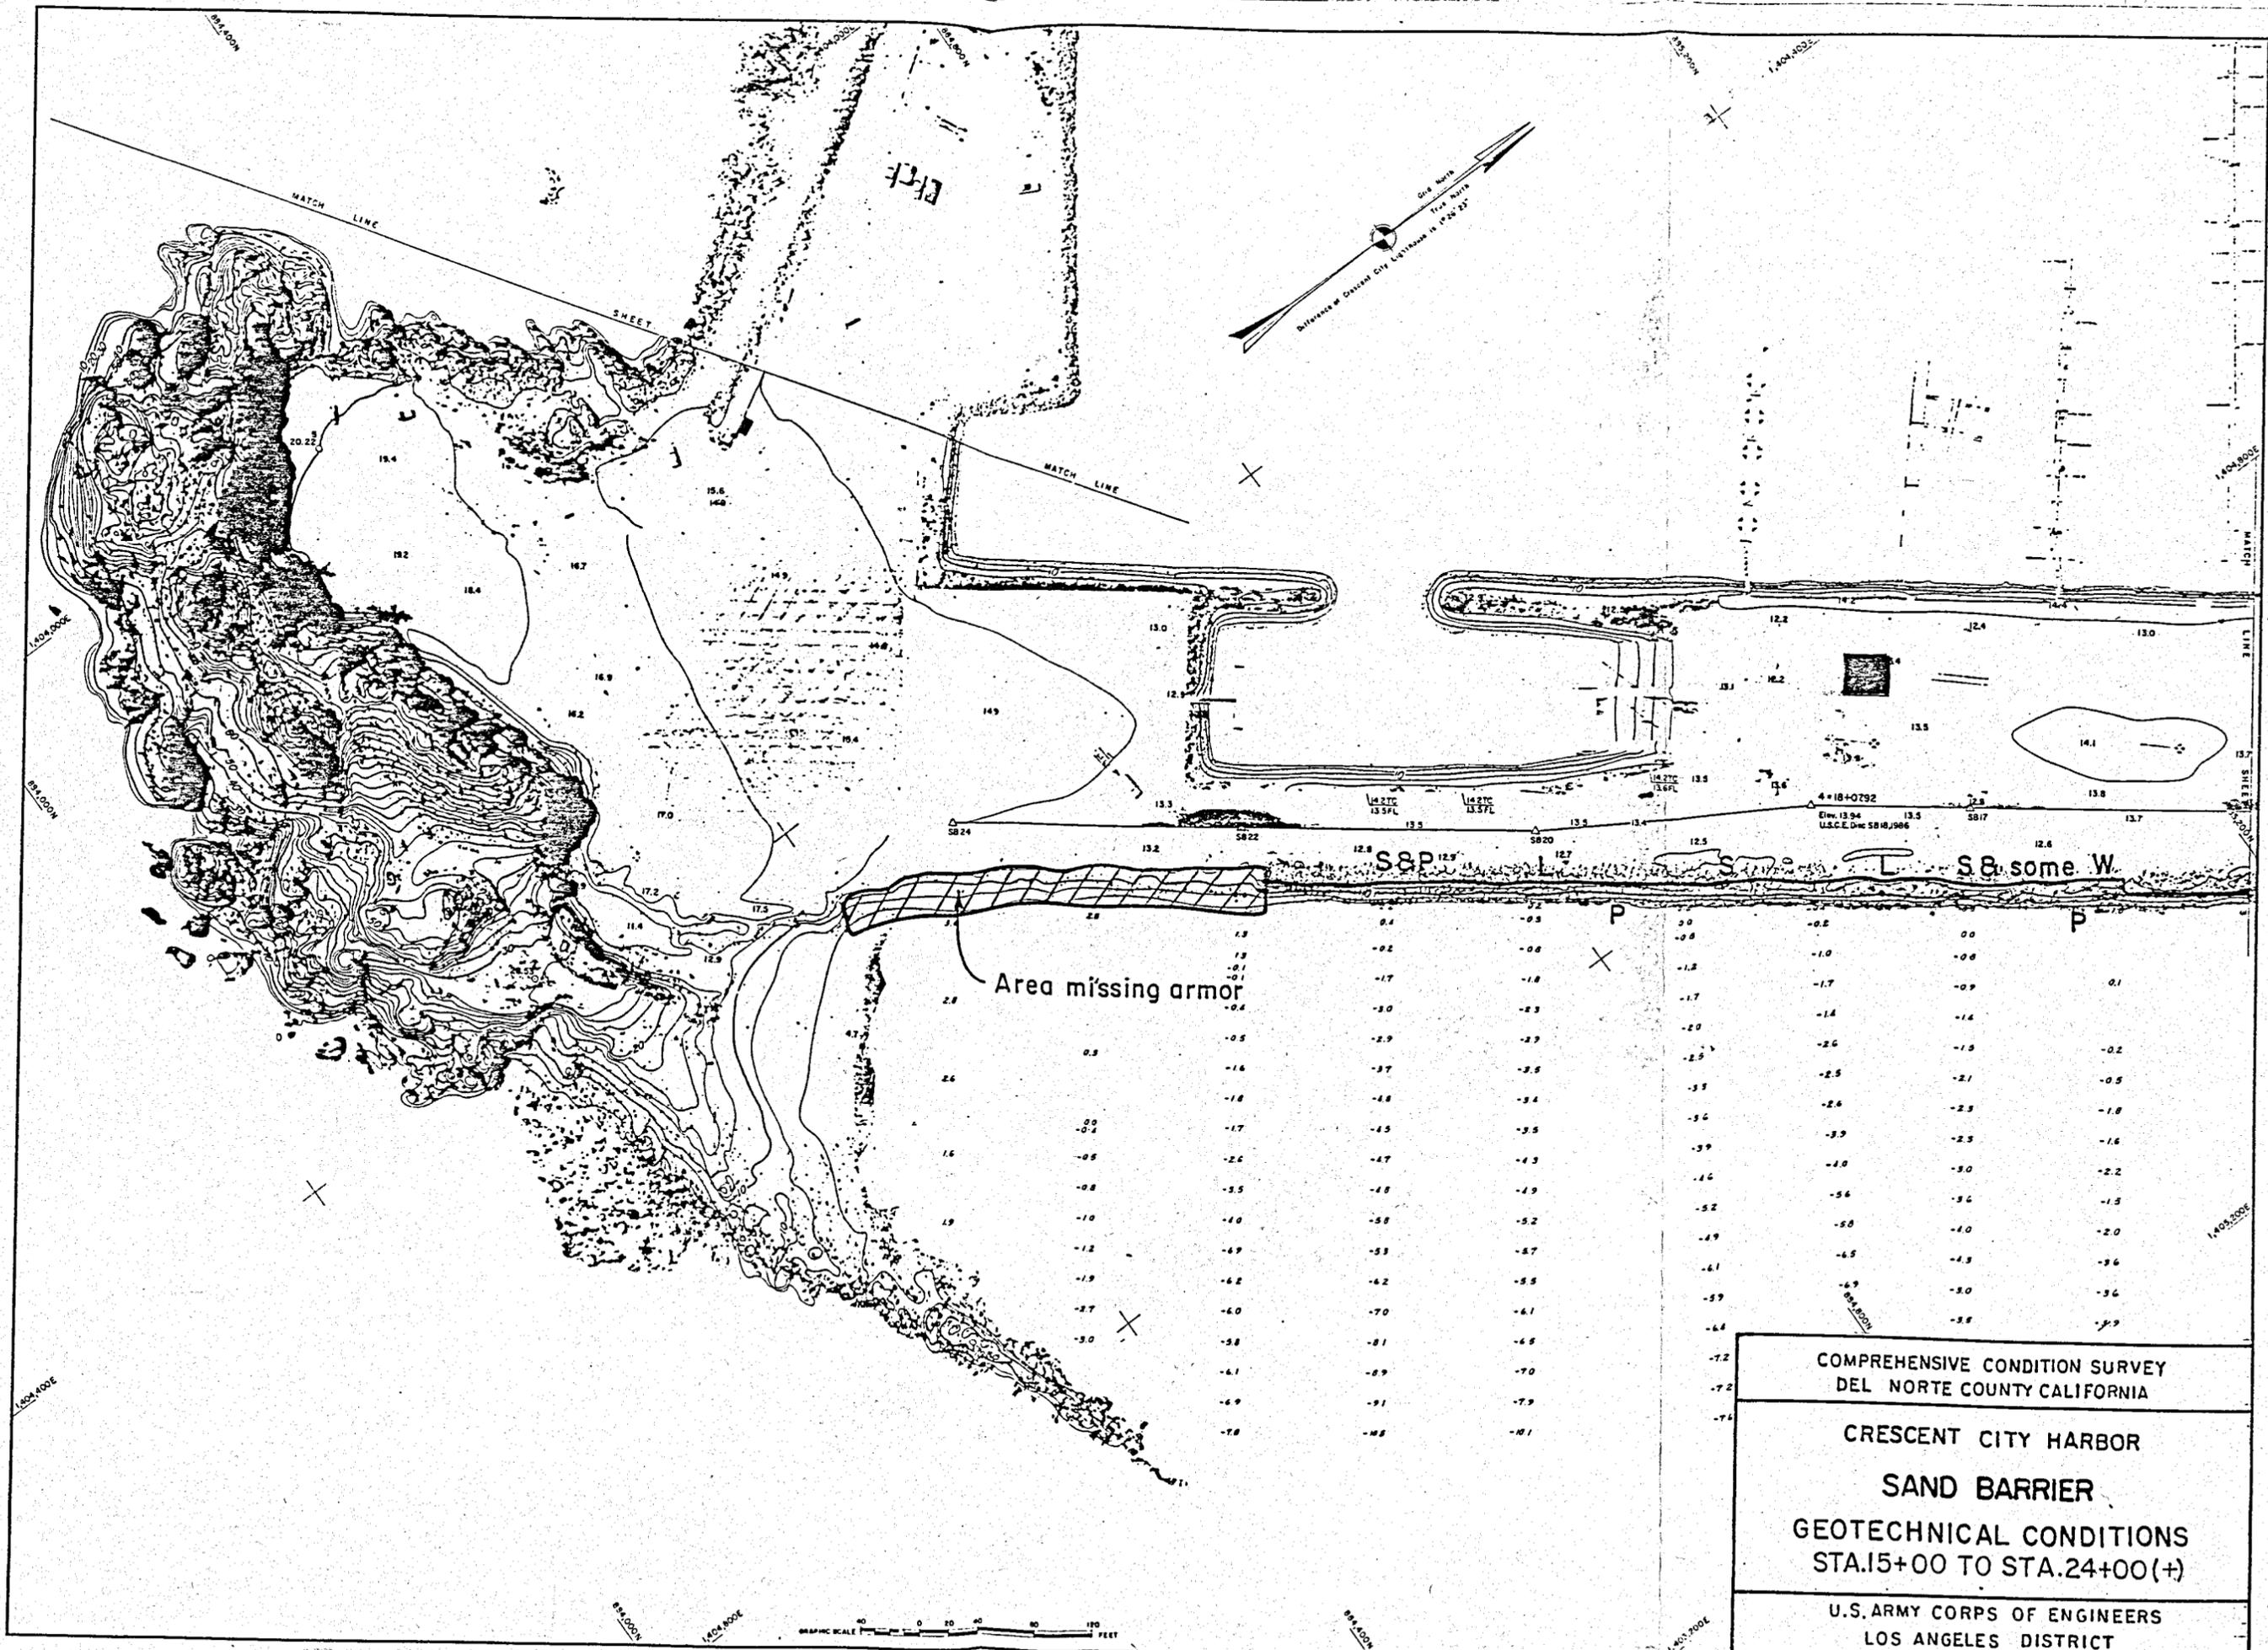
Area missing armor

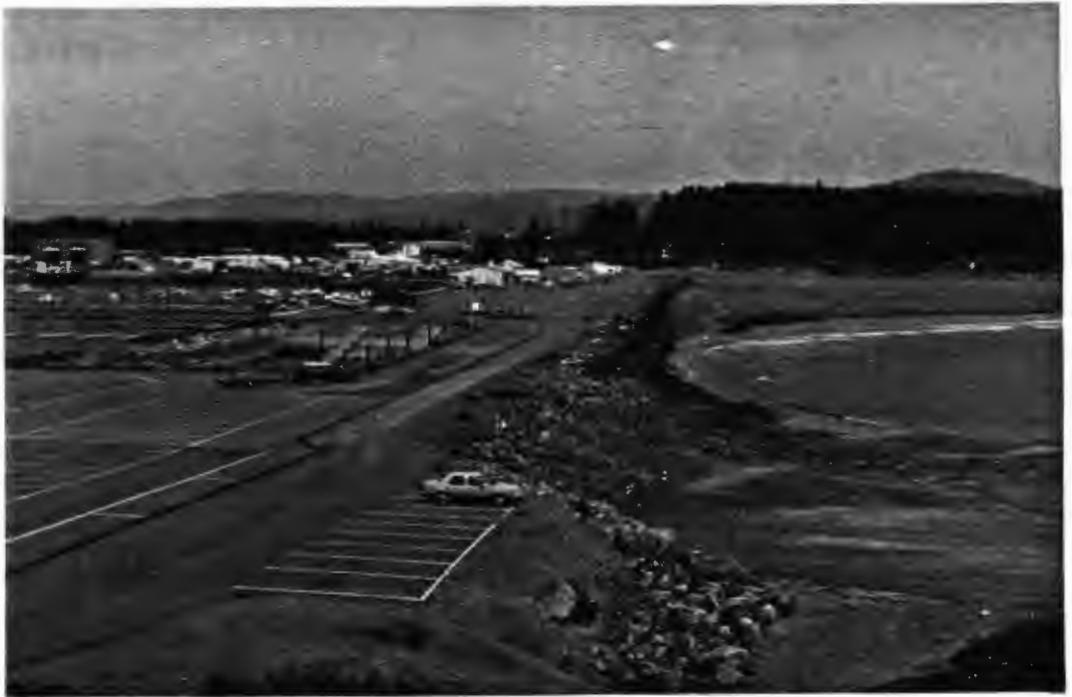
1. SAND BARRIER. The barrier from the Whaler Island towards shore. Note harbor facilities up to the crest and the area scalped of armor just above the car. April 1986

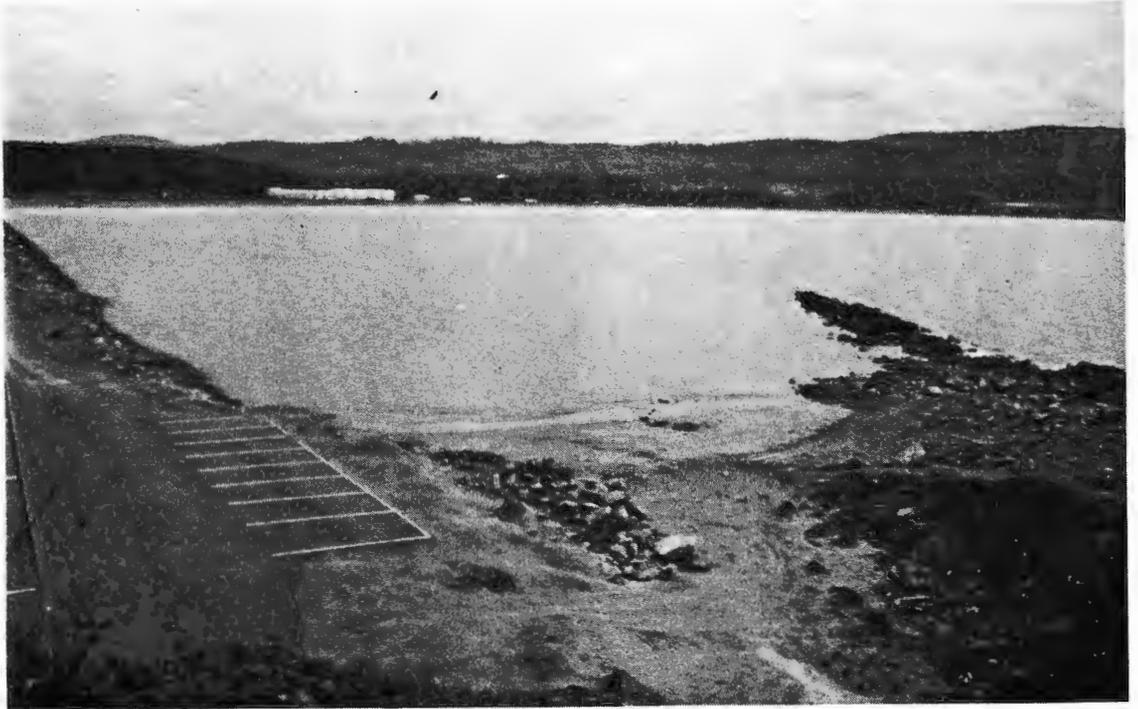
3. SAND BARRIER. Groin on right constructed from armor scalped from end of barrier on the left. April 1986

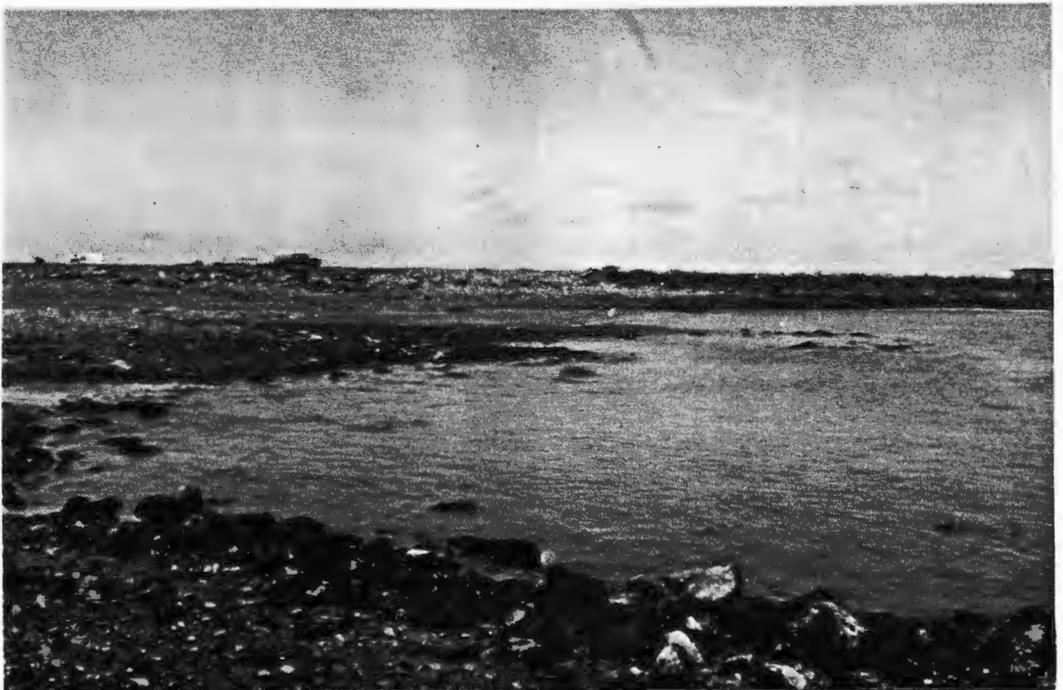
4. SAND BARRIER. End of armor at station 21+95 and scalped slope on the left. April 1986

The recommended short-term rehabilitation program for Crescent City Harbor Inner Breakwater and Sand Barrier consists of replacement of missing armor stones for the reach between stations 21+95 and 24+35. For the inner breakwater the program is to repair the eroded section against the diaphragm using concrete.

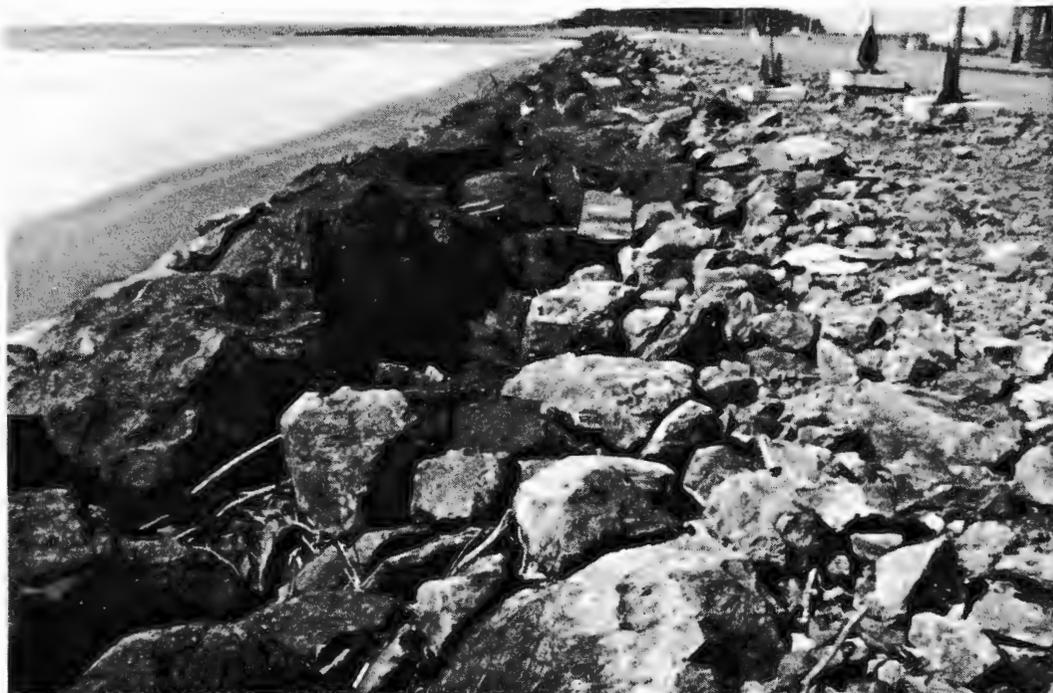
5. SAND BARRIER. Crest at station 9+00 with rock from harbor facilities on the right. Note the small depression in left center where the crest was not filled behind the original parapet wall. April 1986

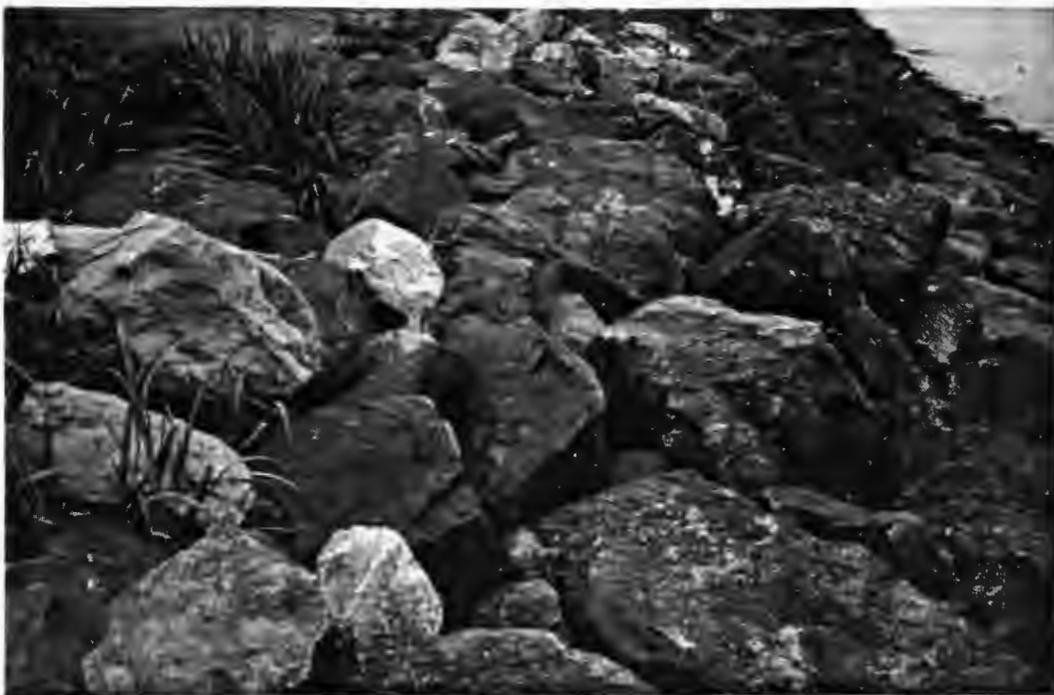
6. SAND BARRIER. Crest at station 21+80. Greenstone on the right and graywacke on the left. July 1986

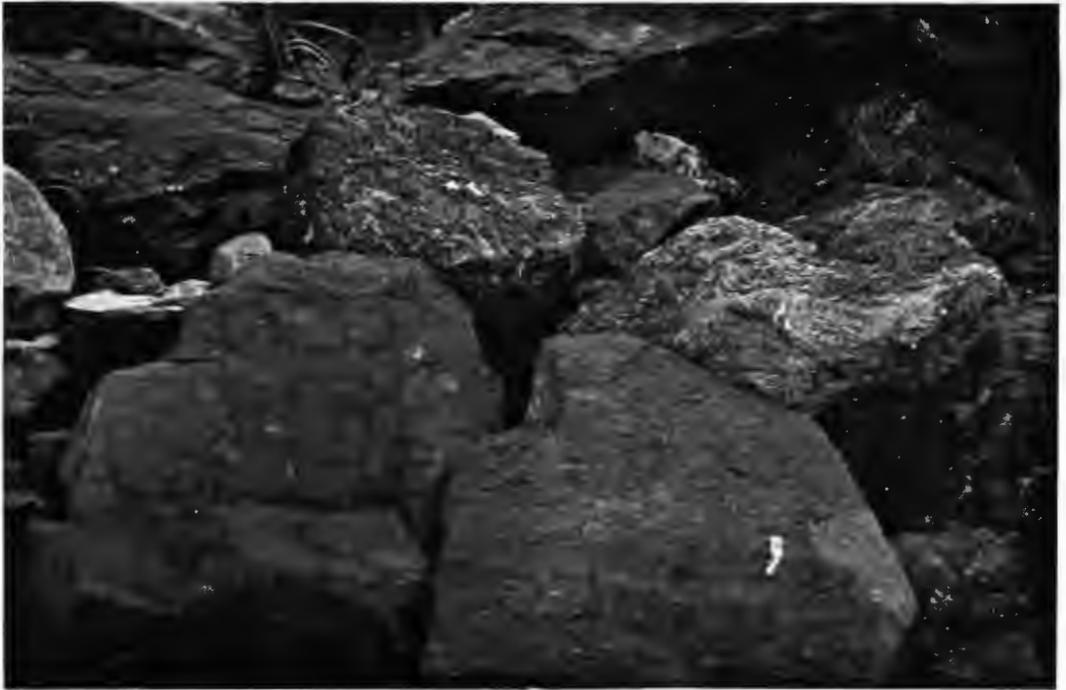
7. SAND BARRIER. Crest at station 21+50. Mottled greenstone armor surrounded by graywacke. Note the seams in the graywacke. July 1986

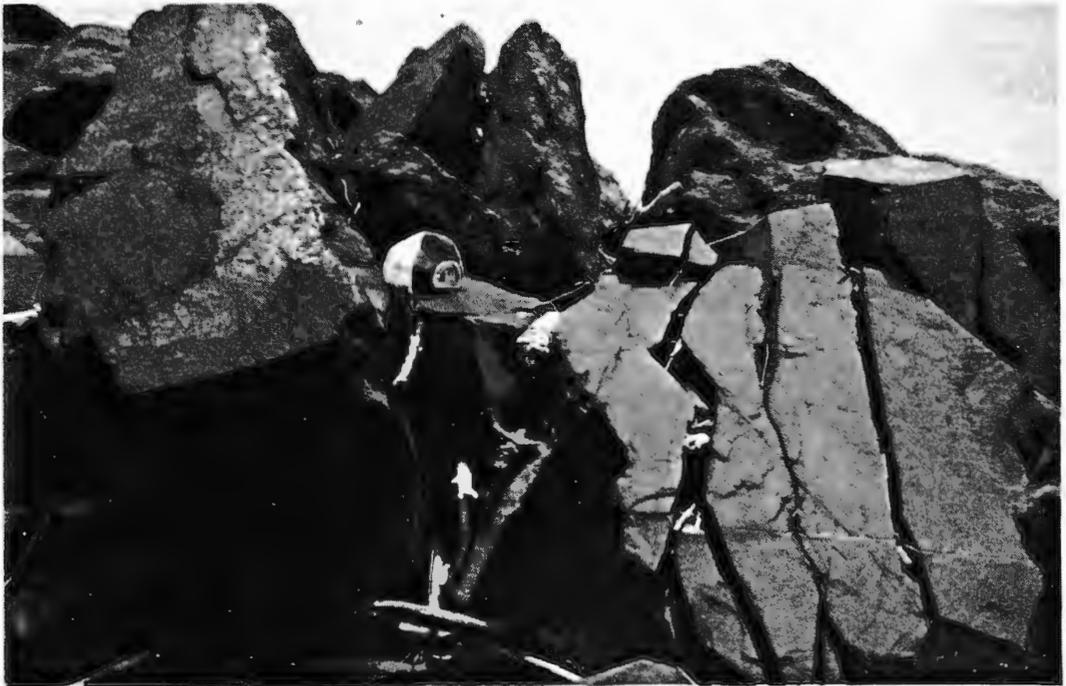
8. SAND BARRIER. Split graywacke at station 14+95. April 1986

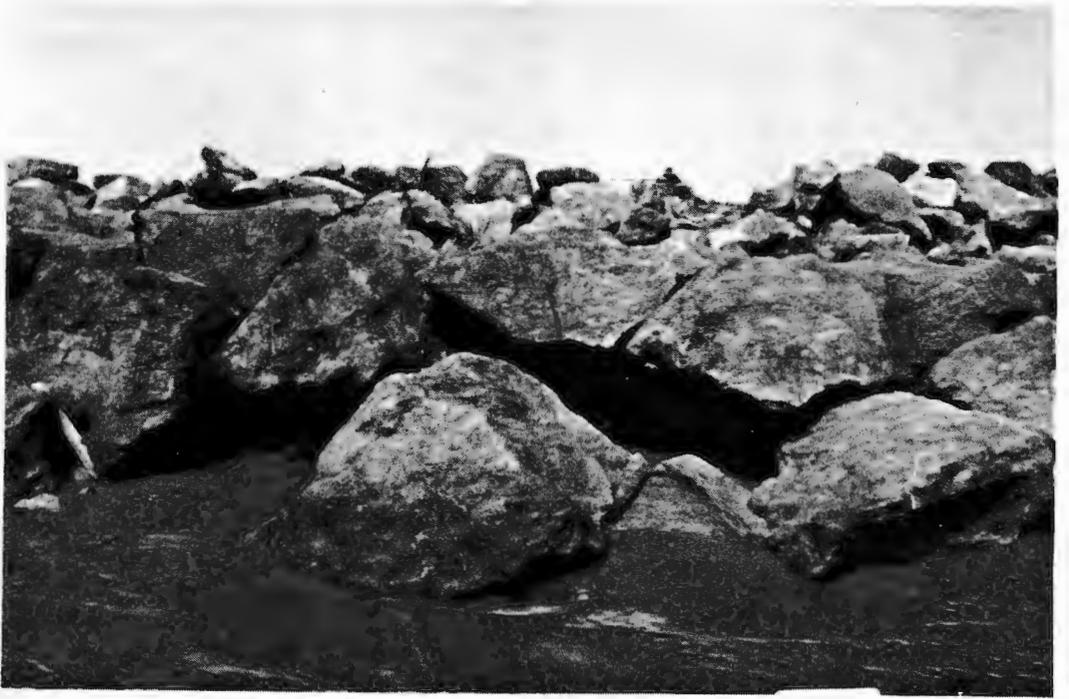
9. SAND BARRIER. Missing armor near station 6+00. April 1986

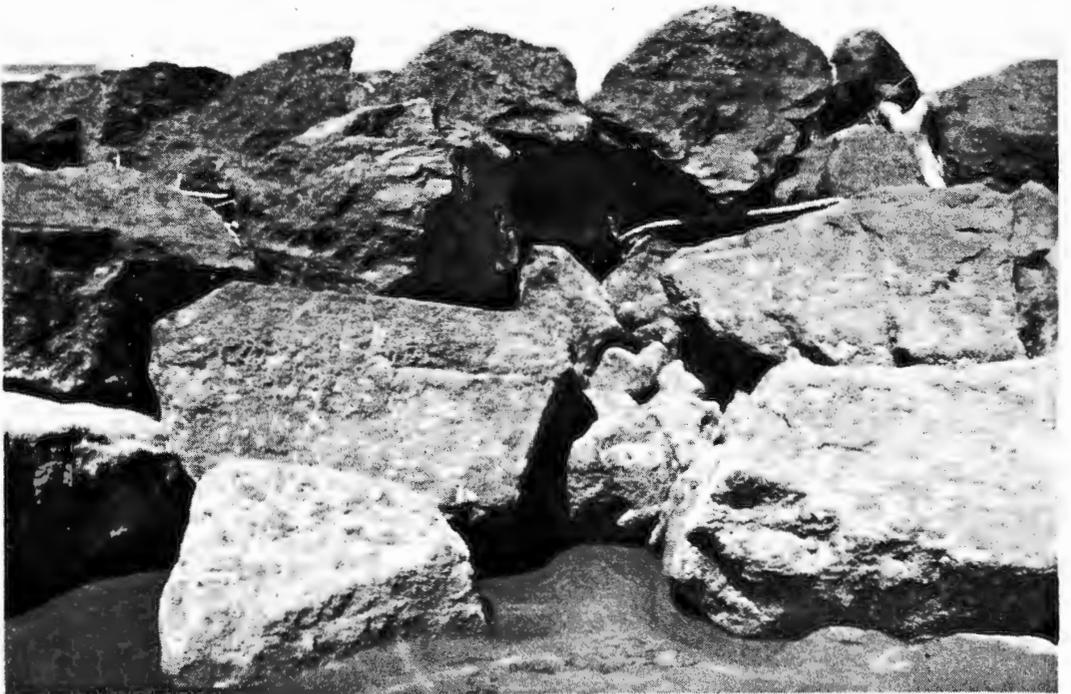
10. SAND BARRIER. Missing armor at station 7+85. Note rounded small stone in hole. April 1986

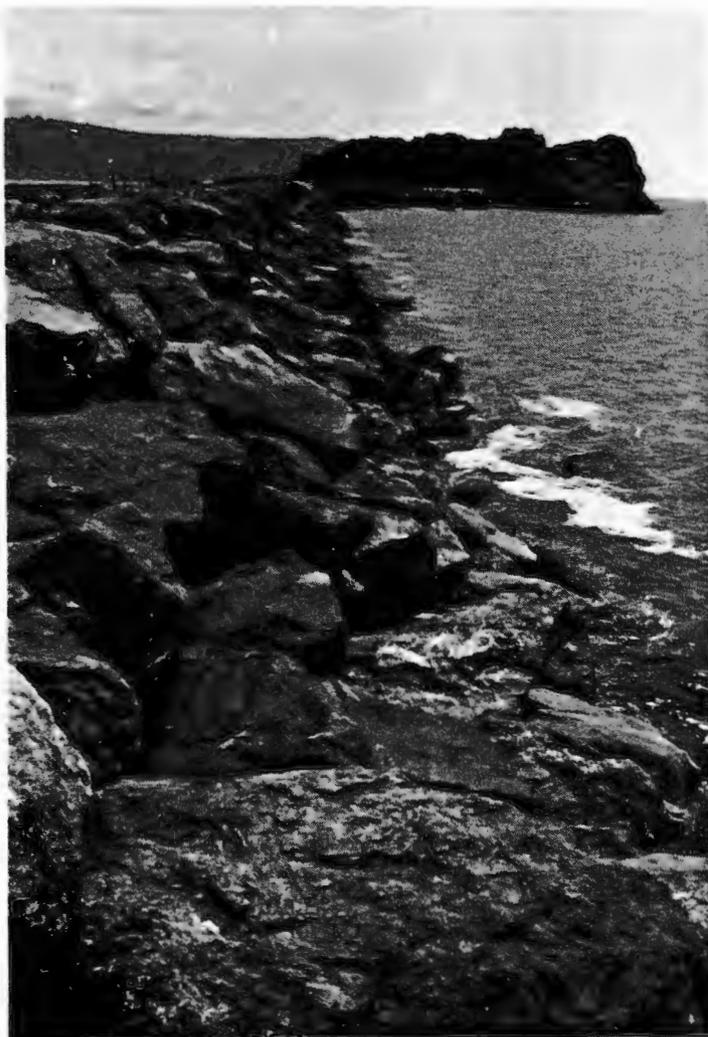
12. INNER BREAKWATER. Ocean slope towards Whaler Island from station 10+00. Note smoothness of the slope. April 1986

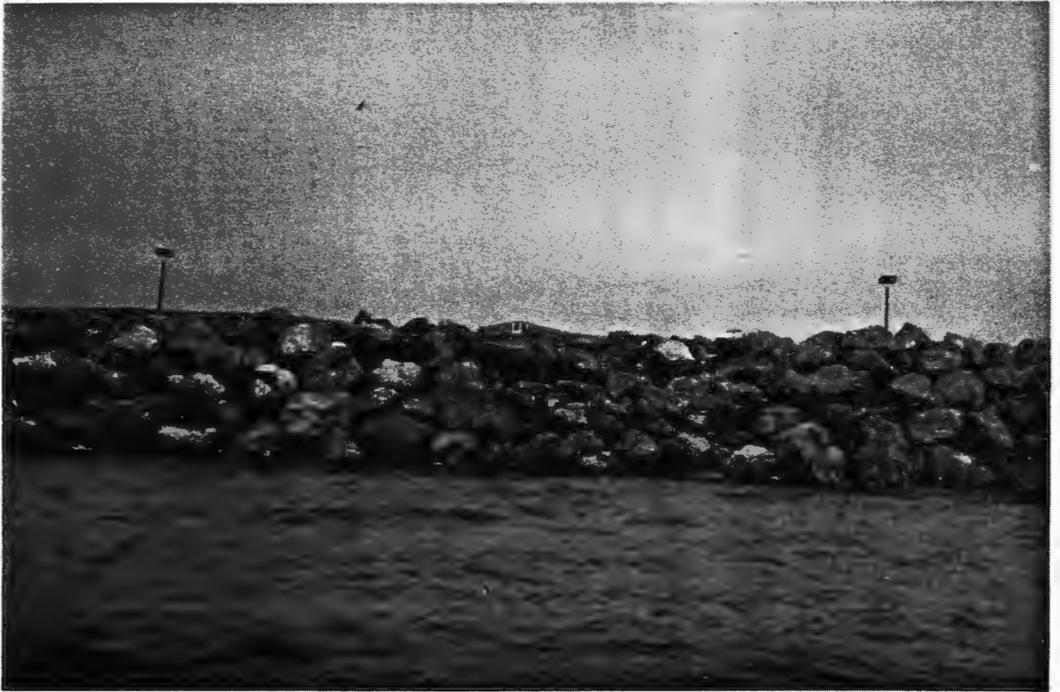
15. INNER BREAKWATER. Ocean slope at station 3+00. Rock is Whaler Island greenstone. July 1986

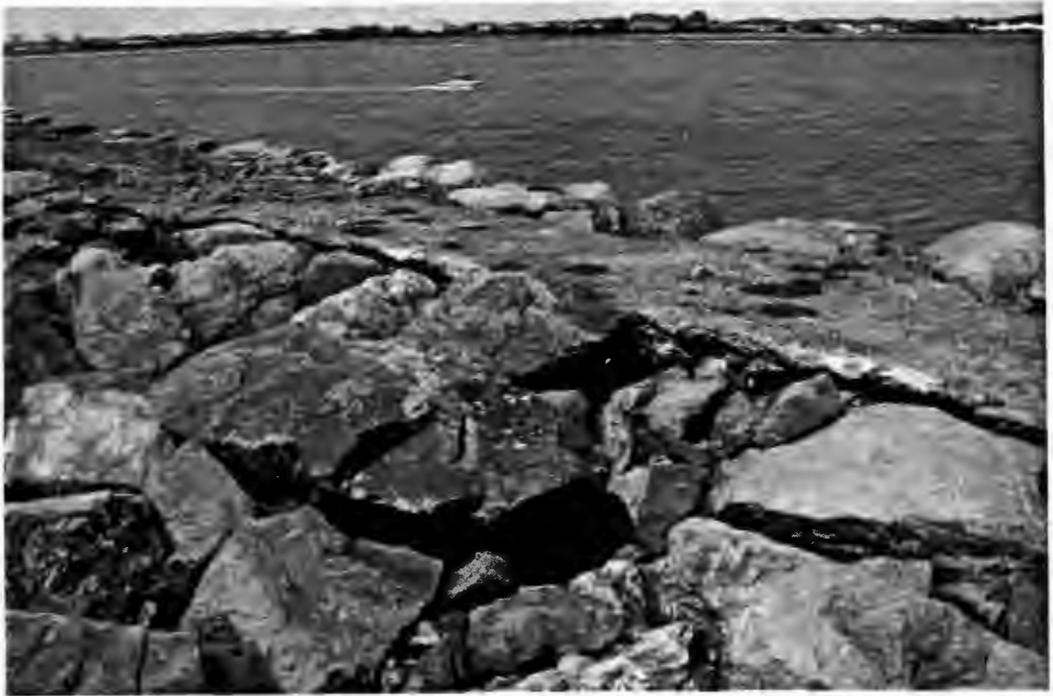
17. INNER BREAKWATER. Ocean side of the diaphragm at station 11+25. Rock is McVay greenstone. April 1986

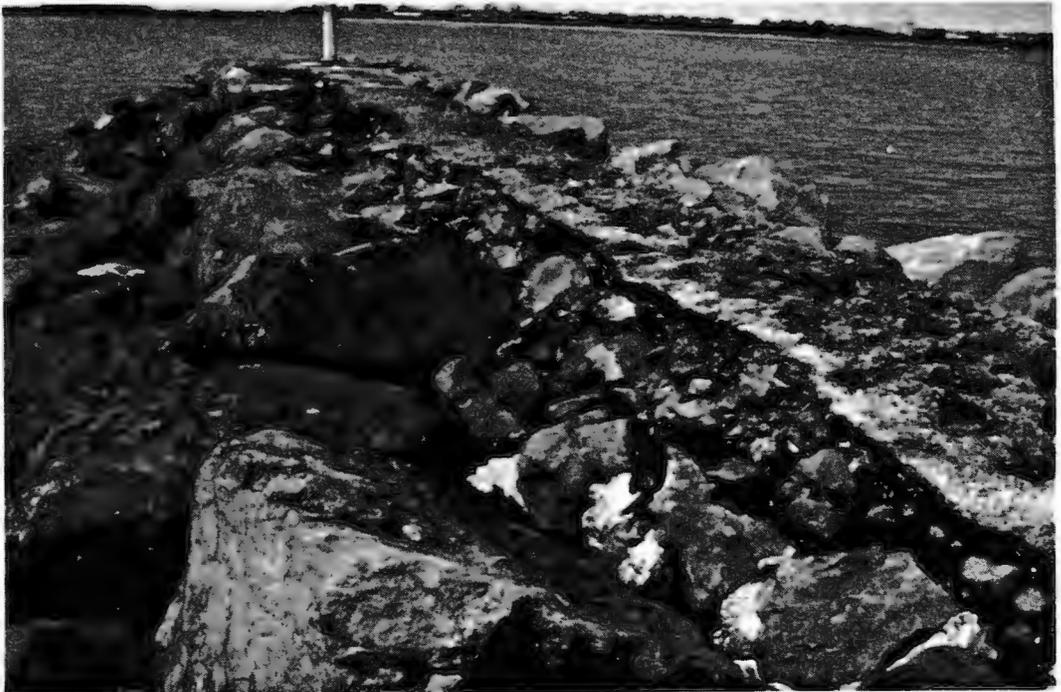
The results of this assessment indicate the inner breakwater is in excellent condition, capable of performing satisfactory for at least another 50 years. The one deficiency is minor erosion along the diaphragm wall from station 13+85 on the ocean side and 14+15 on the harbor side to station 15+00 near its end. Also, several dislodged stones were observed on the ocean floor near the sections repaired in 1984 and a larger zone where the armor was removed in 1972 to add the 400-foot extension.

18. INNER BREAKWATER. Eroded crest against the ocean side of the diaphragm, from station 14+40 towards the head. April 1986
