Humboldt Bay Water Control Structure Inventory, Assessment, and Mapping, Final Report

Humboldt Bay Water Control Structure Inventory, Assessment, and Mapping

**Humboldt Bay Water Control Structure Inventory,
Assessment, and Mapping Project
Final Report**

October 30, 2007

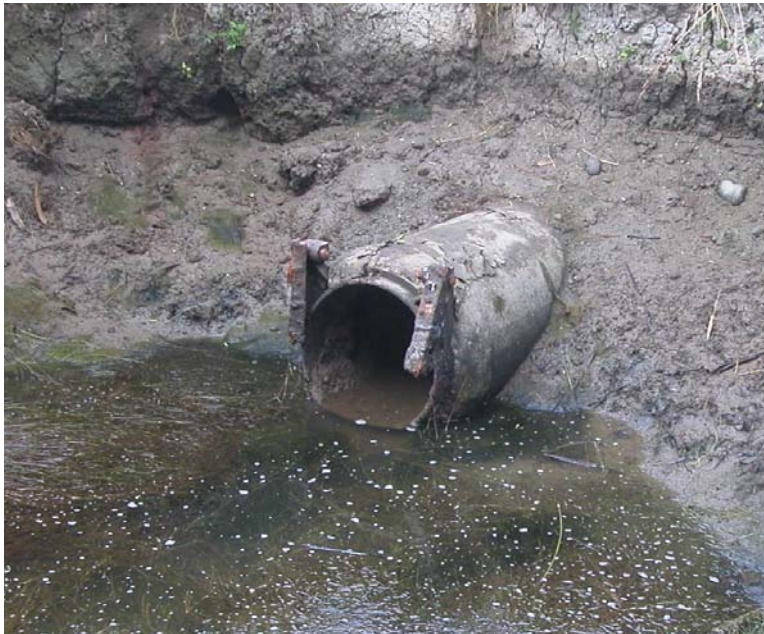
Figure 1. Example of a concrete pipe culvert with failed (missing) tidegate.
