Ecocultural Monitoring and Erosion Mitigation in Powers Creek, a Baduwa't Tributary, in Blue Lake, California

Environmental Science & Management: Ecological Restoration Capstone 2024

California Polytechnic University, Humboldt

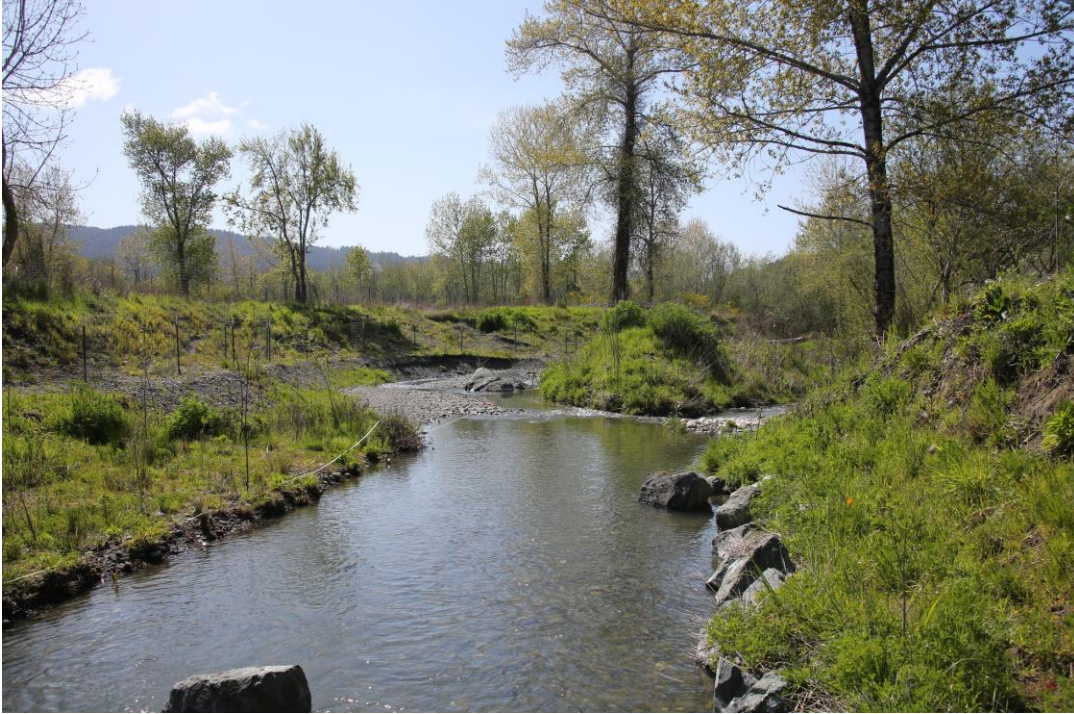
Figure 2: May 2023 pre-erosion. Blue Lake Rancheria; Facing downstream Powers Creek with the destabilized bank on the left. (Jacob Pounds).

The collective utilization of the aforementioned bioengineering methods proved to be effective (*Figures 2 & 3*). Several sizable precipitation events occurred during and after implementation. More specifically, during the addition of *Juncus* and *Salix* onto the eroding slope, we experienced a minor erosion event which covered up the majority of the individuals we

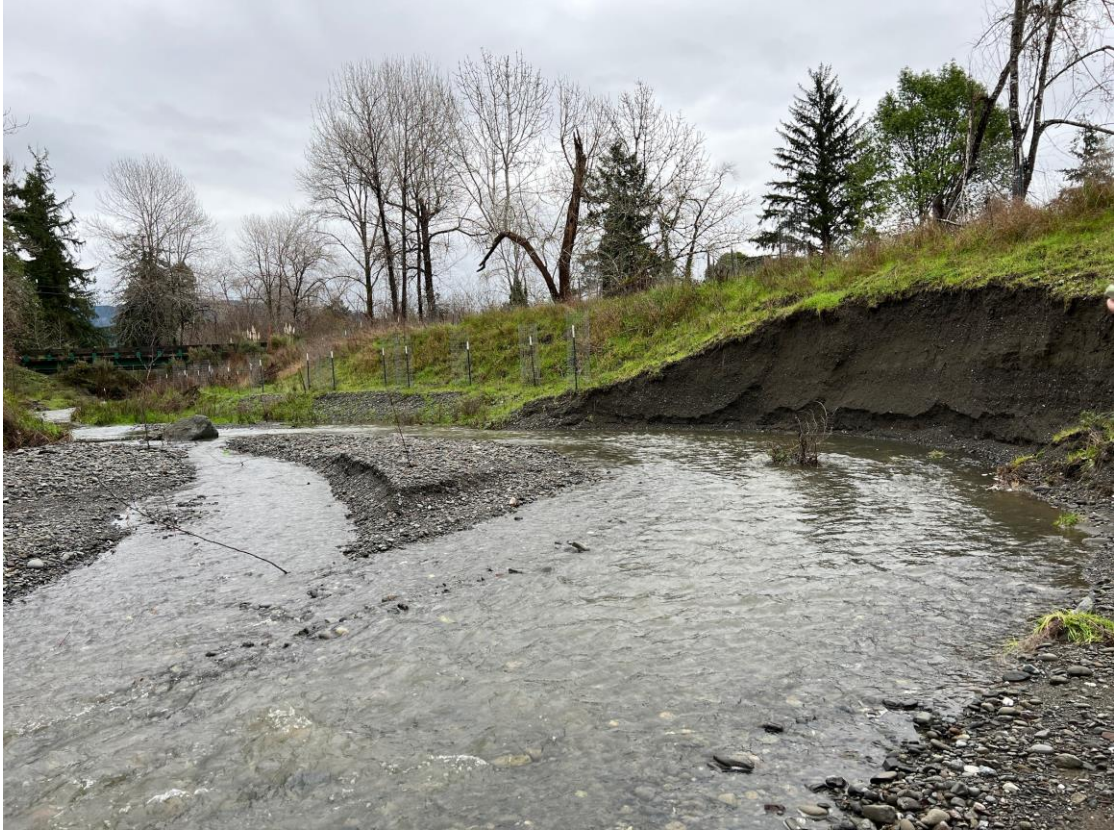
Figure 3: February 2024 post-erosion. Facing upstream Powers Creek with destabilized bank erosion on the right (Daniel Price).

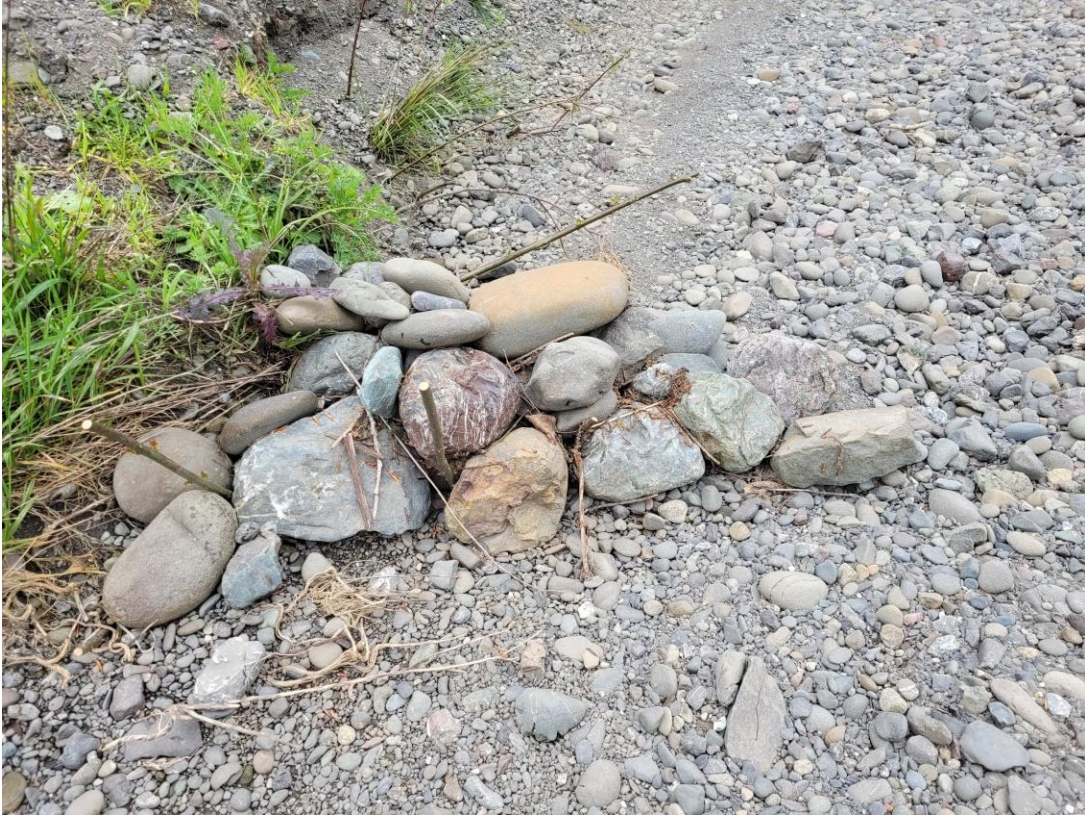
Figure 4: Constructed Rock weirs (Daniel Price).

Our team diverted hydraulic energy away from the affected bank to limit continued erosion at Powers Creek. The team added two stone weirs (Figure 4) to direct the energy away from the stream while still allowing for fish passage as needed. The large stones were sourced from Powers Creek to minimize cost and the need for heavy machinery. Rough-edged rocks were placed near the bottom to enhance stability while smoother rocks were placed on top. The upstream weir was slightly smaller than its counterpart and placed at the toe of the eroding bank, with the larger, secondary weir placed approximately a meter downstream. In between the rock weirs, we placed *Salix* stakes to stabilize the weirs. On the eroded bank itself, we established transplants of *Juncus* and *Salix* (Figure 5). *Juncus* individuals were dug up from the floodplain and deposited along the base of the eroding riverbank. *Salix* stakes and whips were taken from nearby mature willows and cut flat on one side and angled on the other; the angled ends were

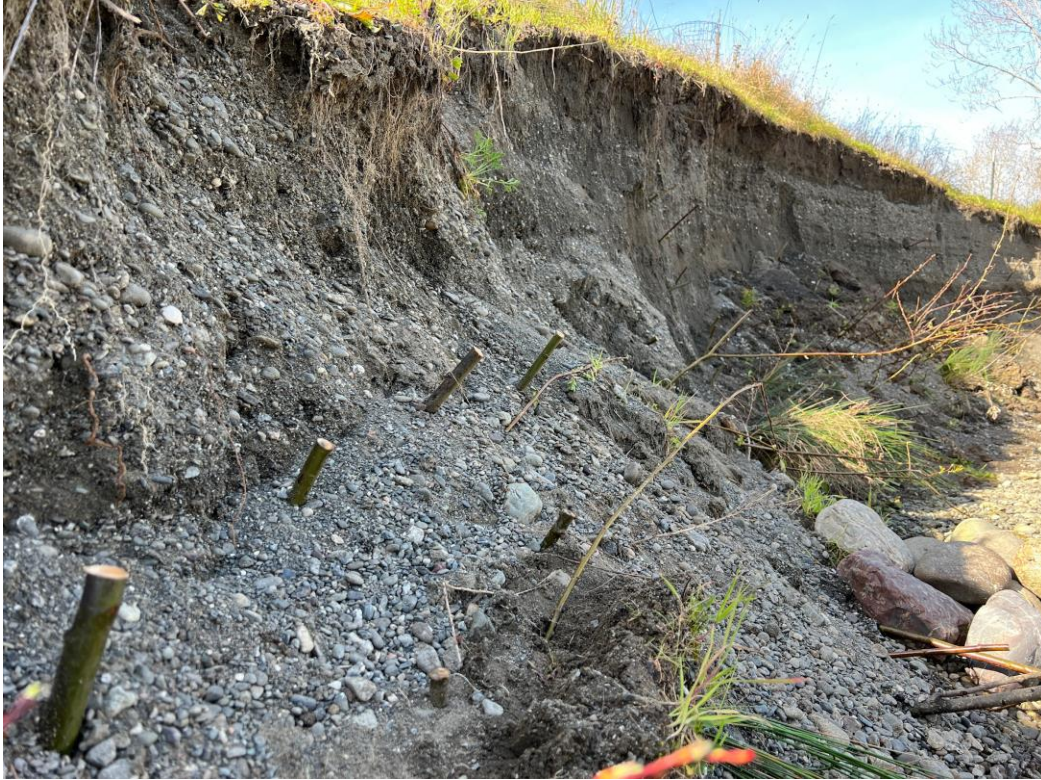
Figure 5: *Salix* spp. and *Juncus* spp. transplant on the eroded bank (Daniel Price).

hammered into the bank with rubber and wooden mallets up (Krabeel, 1933). Hammering too hard can cause willow stakes to split and provide less structural advantage, so we took precautions to ensure the specimens were placed gently.

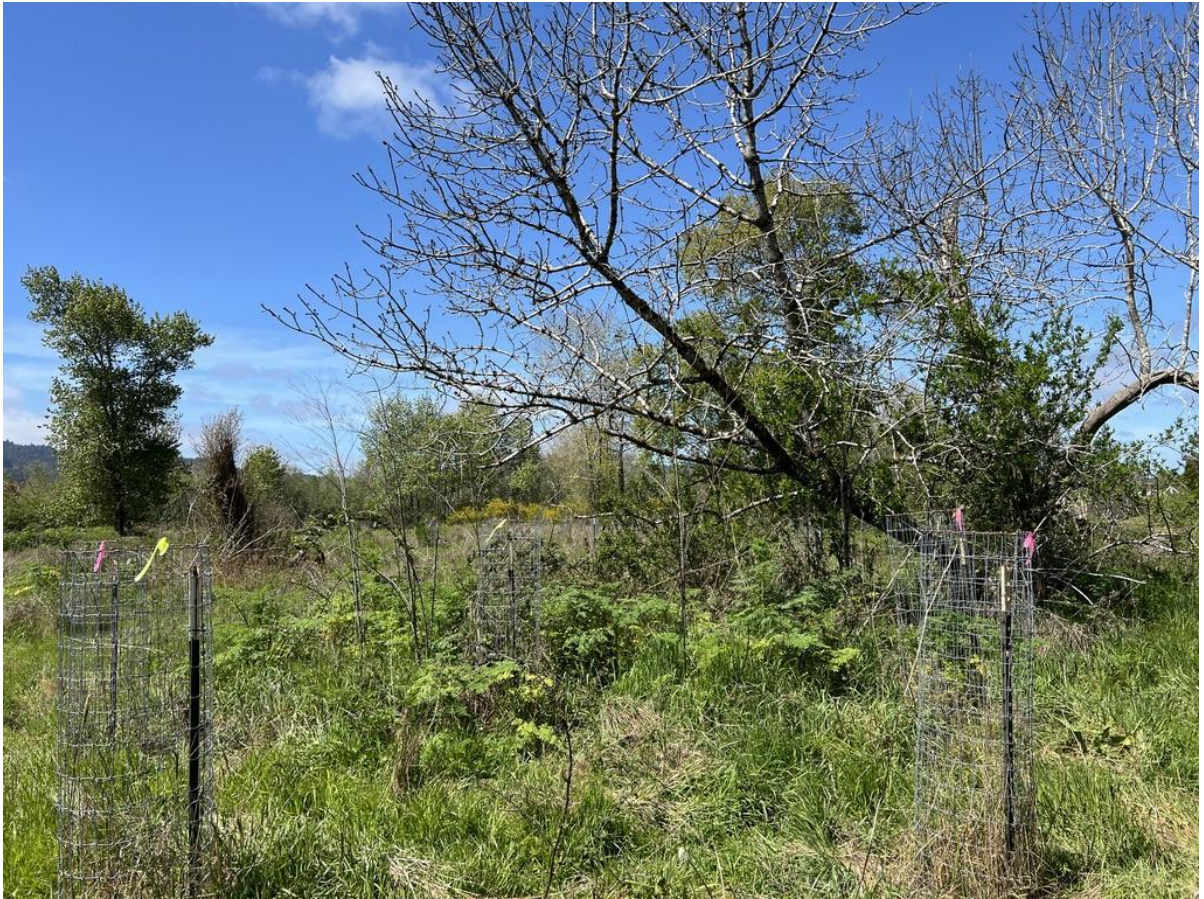
Figure 6: Flagging present on cages (Daniel Price).

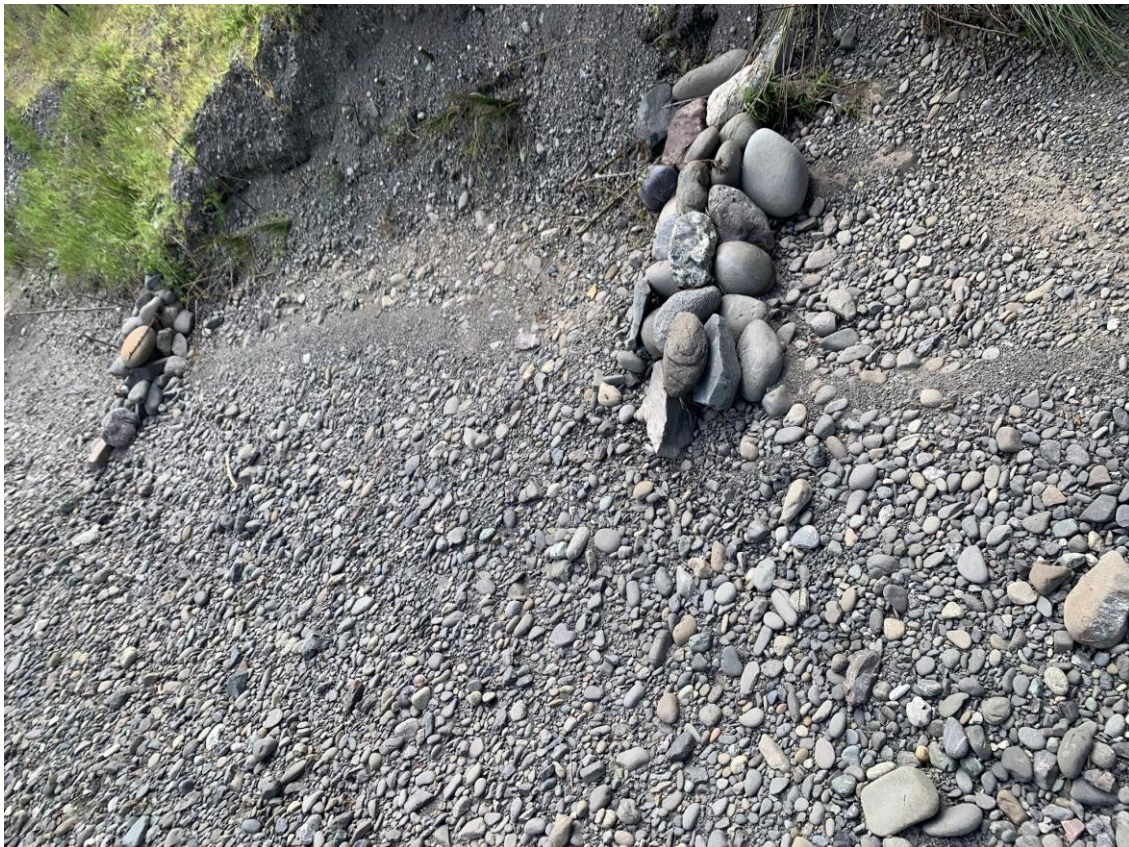
Figure 7: Fine sediment behind rock weirs at the toe of the eroded slope (Sebastian Castillo)

had planted. Despite this, the vegetation remained in place, and the *Salix* had begun to sprout in the following weeks. Though we did not gather quantitative data regarding water velocity and erosion rates before and after on-site implementation, qualitative interactions with the site made clear that these methods were useful in the case of Powers Creek. For instance, sediment buildup on the weirs is indicative of decreased water velocity, as slower water allows smaller sediment size classes to settle out (*Figure 7*) (Salant et al., 2012). In streams with heightened velocities, which are usually also incised streams lacking in structural complexity, fine sediments are being moved too quickly to be deposited onto the riverbed (Salant et al., 2012). In short, adding complexity to the stream succeeded in developing a slow-water habitat in Powers Creek.

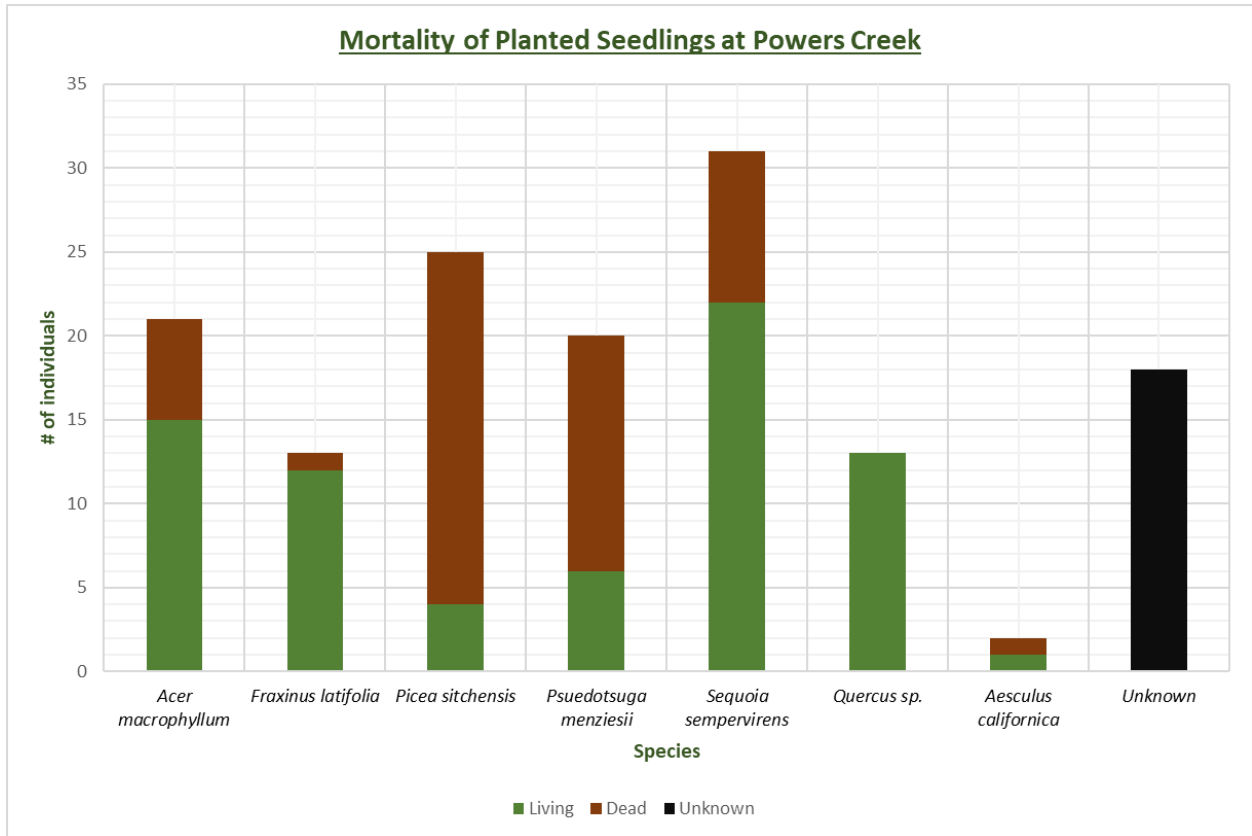
Figure 8: This stacked bar chart indicates the species planted near Powers Creek in 2020 and 2021. The green portion of the chart indicates a living individual, and the brown portion of the chart indicates a dead individual. The black bar on the right-hand side of the chart is representative of our margin of error, as not all species on site were able to be identified.

Similar implications are examined in Figure 8. This graph provides a visual representation of the relative survival and mortality rates for each planted species identified in the Powers Creek riparian zone. For instance, it becomes apparent that though the greatest number of *Sequoia* survived, *Quercus* and *Fraxinus* took the lead in terms of percentage. Furthermore, the gray bar is indicative of individuals we were not able to identify, making it

clear that the margin of error within this data set must be granted careful consideration (*Figure 8*). Additionally, it is important to note that individuals included in the unknown category may have been a species type that was not included in our data collection (*Table 1*). In other words, there are potential species that experienced 100% mortality, for which data was never collected.
