Effects of Beaver Dam Analogs on stream channel complexity and overbank flow recurrence on McGarvey Creek (Del Norte County, CA)

Ecological Restoration Capstone (ESM 455)

Department of Environmental Science & Management

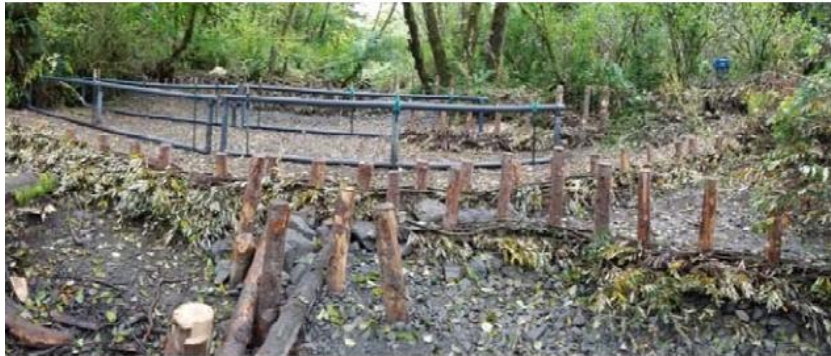
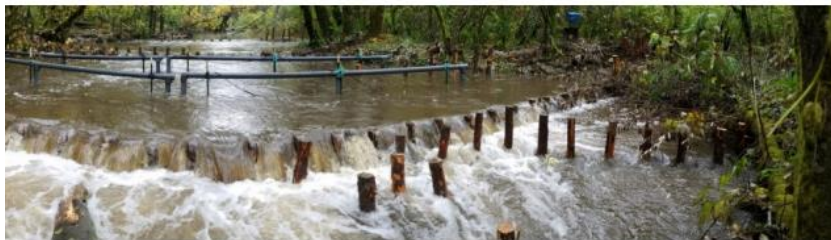
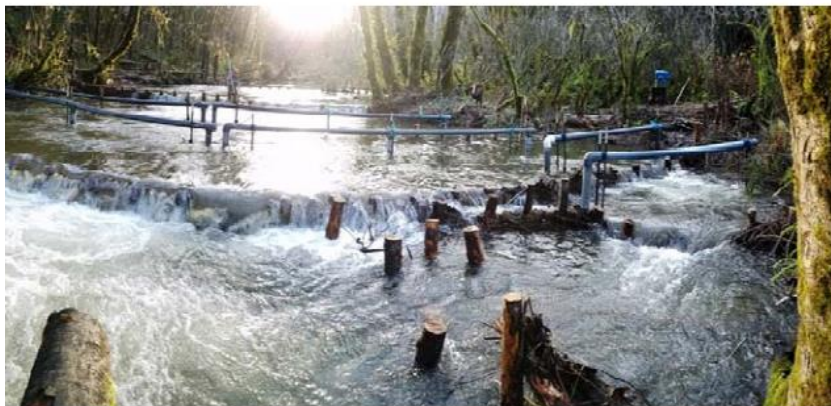
Photos of McGarvey Creek BDAs (photo credit: Sarah Beesley)

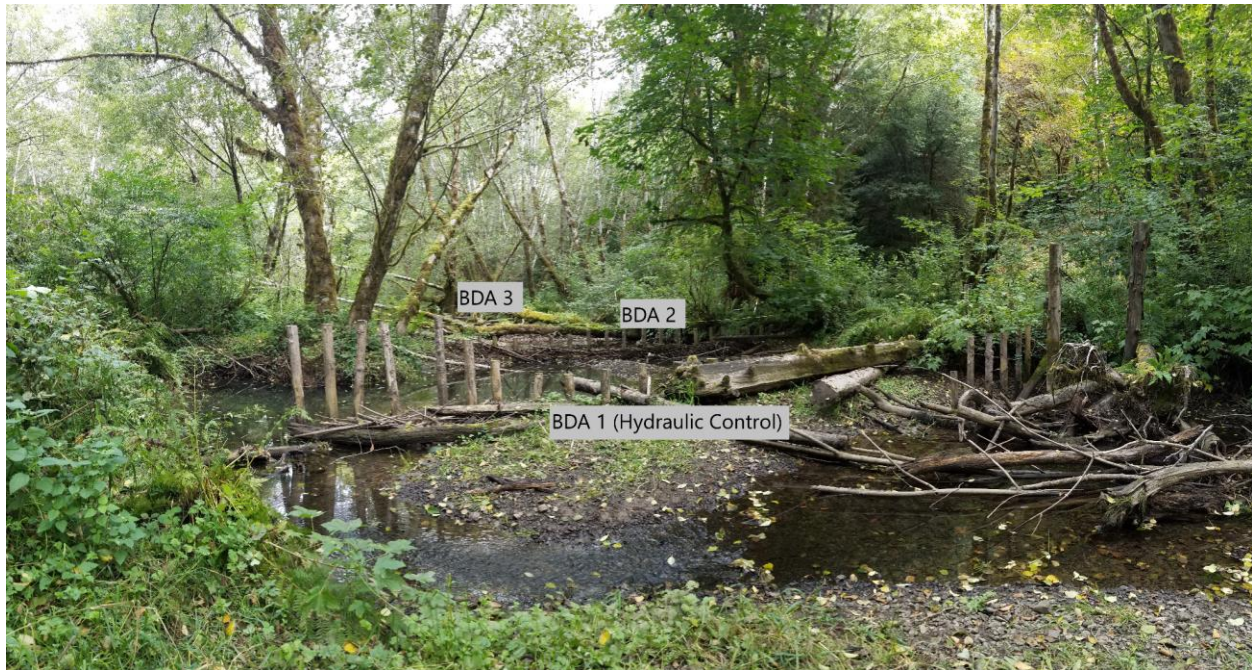
Figure 3. Photograph of the McGarvey Creek study site (looking downstream) with the locations of the three BDAs. BDA 3 is not visible in the image, but its relative location downstream of BDA 2 is labeled. Photo taken by J. Anderson on 10/10/2021.

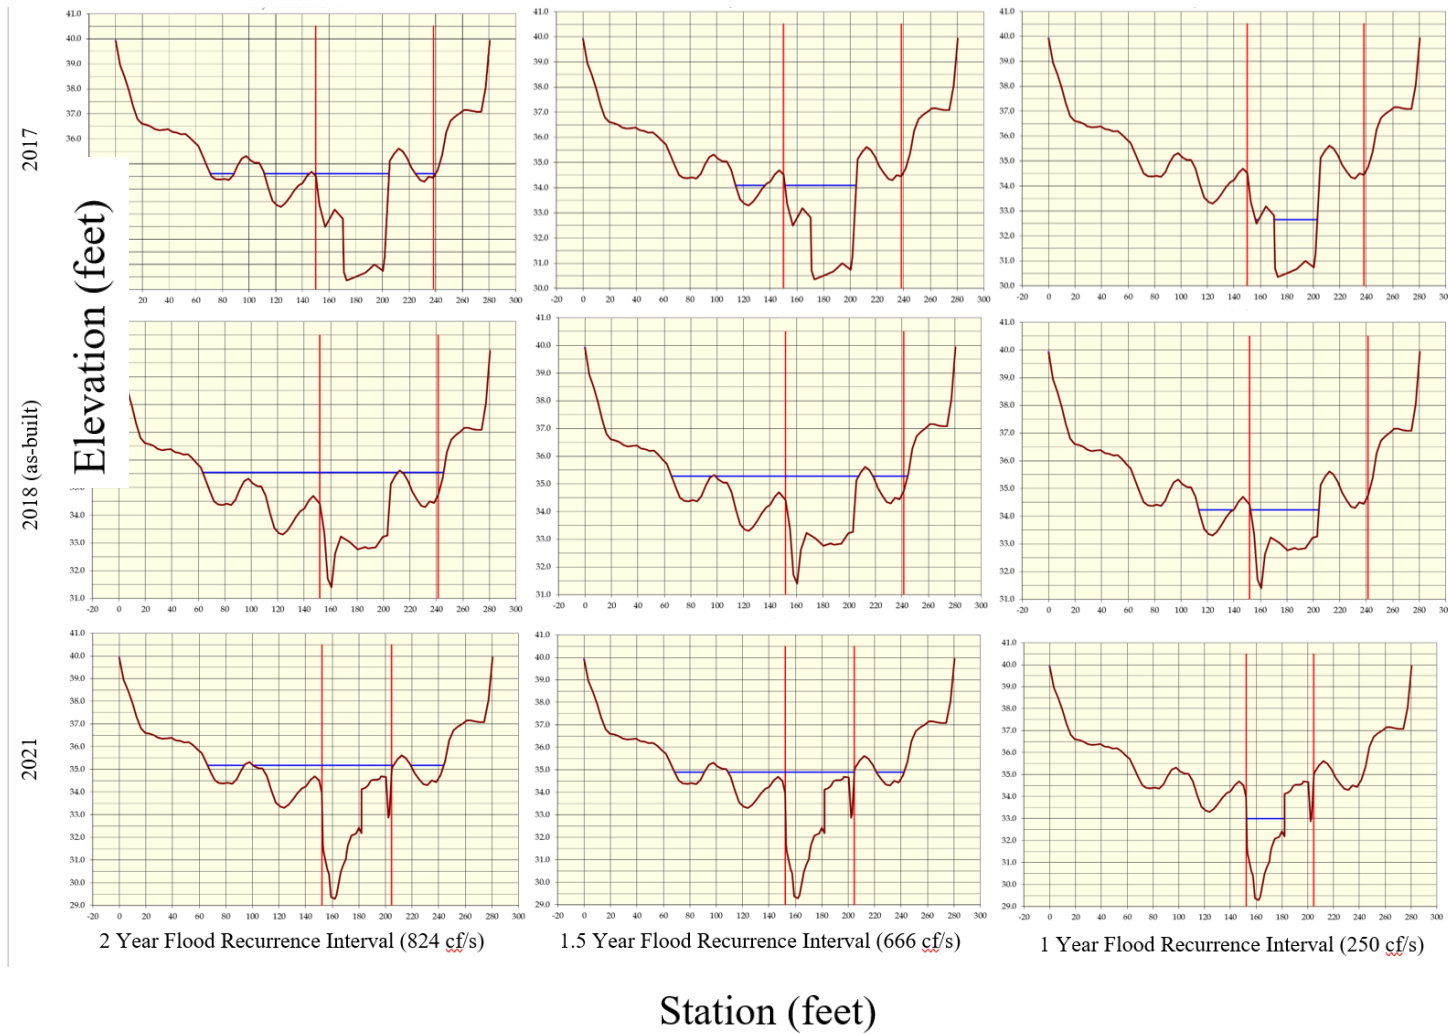
Figure 6: Cross sectional profiles of BDA crest controls (2017, 2018, and 2021) at discharge rates correlating with flood recurrence intervals (Appendix A2). Blue line represents the overbank flow of McGarvey Creek into adjacent hydrologic units.

Results produced from use of the NRCS Tool are presented in Table 1 and Figure 6. Results indicated that the 2018 As-Built site on McGarvey Creek's crest had the highest wetted perimeter during 1-year flood recurrence flows (250 cf/s). Wetted perimeter is defined as the width of the streambed and stream banks in contact with water for an individual cross section; it was used to measure the availability of aquatic habitat over a range of discharges (USGS, 2016). Over a 1.5-year flood recurrence interval, the wetted perimeter was significantly higher in the 2018 As-Built dataset compared to the 2017 Pre-Project data. Over a 1-year flood recurrence interval flow, water velocity (ft/s) was calculated to be significantly higher in 2017 and 2021 relative to 2018 As-Built velocity (Appendix 1A). The 1.5- and 2-year flood recurrence interval flows showed the highest velocity with the 2018 As-Built crest having the lowest velocity among the three different surveys. The 2021 velocity data showed the 2017 pre-built conditions to have the highest values with the 2021 crest values as the second highest. Shear stress indicates how much force is being applied to the channel bed (Dingman, 2009) and was compared across the three datasets (2017 Pre-Project, 2018 As-Built, and 2021 Post-Project) as well. Shear stress calculations indicated that discharge at a 1-year flood recurrence interval was significantly higher in 2021 and 2017 than it was in the 2018 As-Built condition (Appendix 1A). For the 1.5-year flood recurrence discharge, the pre-built 2017 crest showed a significantly higher shear value relative to As-Built and Post-Project conditions.

Inputting discharge values (Appendix A2) corresponding with flood recurrence intervals at McGarvey Creek indicated that the addition of BDA 1 did increase floodplain connectivity. At a discharge of 824 cf/s, the addition of BDA 1 (based on the As-Built and Post-Project survey data) showed higher water surface elevation in adjacent floodplains than the 2017 Pre-Project

conditions. 2018 As-Built and 2021 Post-Project conditions at BDA 1 showed greater floodplain connectivity at a discharge of 666 cf/s, relative to the Pre-Project condition (Figure 6). No difference in floodplain connectivity to adjacent hydrologic units was observed among the Pre- and Post-Project conditions at a discharge of 250 cf/s. Comparing calculated hydraulic parameters for all the input design discharges (Q1, Q1.5, and Q2.0) across the three datasets (2021, 2018, and 2017) indicated floodplain connectivity was greatest for the 2018 As-Built conditions and that floodplain connectivity was intermediate for the Post-Project conditions and lowest at the 2017 Pre-Project conditions.

Our overbank flow results (Figure 6) shed light on how BDAs at McGarvey Creek Site 1 influenced connectivity of the stream to adjacent floodplain habitats. At Q1-, Q1.5-, and Q2, we found that without BDAs present in 2017, there was little or low floodplain connectivity at the site. With the addition of BDA 1, floodplain connectivity greatly increased, as the stream's bankfull height was greatest in 2018 and there were intermediate increases in floodplain connectivity and bankfull height during the Post-Project phase (2021). Bankfull is known as the flow that fills a channel up to the top of its banks prior to flooding (NRCS, 2021). The increased floodplain connectivity observed in 2018 was most likely related to the installation of BDA 1 which caused more water to spread laterally and downstream of the dams relative to the unobstructed condition pre-project (Westbrook et al., 2006). Studies have found that beaver dams naturally increase overbank flow to adjacent units (Wohl, 2021), and our 2021 dataset showed that BDA site 1 added a level of stream complexity that was previously offered by the North American Beaver (*Castor canadensis*). Due to the population reduction of these ecosystem engineers along the Klamath River, the implementation of BDAs along streams with little stream complexity may prove to be a vital component of river restoration and floodplain
