A COMPARISON OF ZINC LEVELS IN RUNOFF FROM RUBBERIZED HOT MIX
ASPHALT AND CONVENTIONAL PAVEMENT

A Project Presented to

Master of Science in Environmental Systems: Environmental Resources Engineering

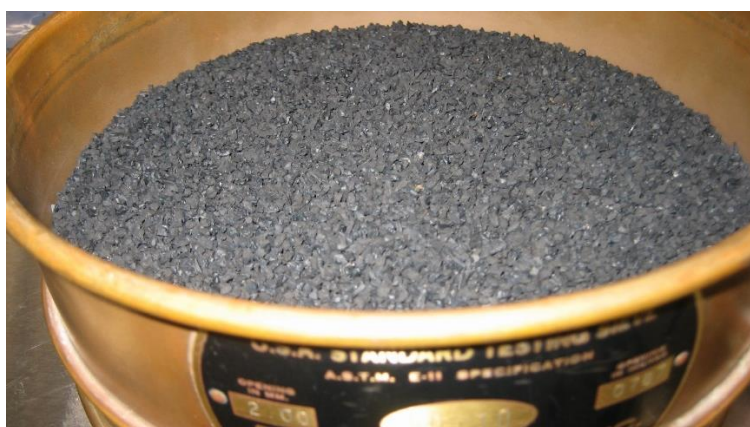
Figure 1: A representative sample of passenger tire crumb rubber that is less than two micrometers in diameter.

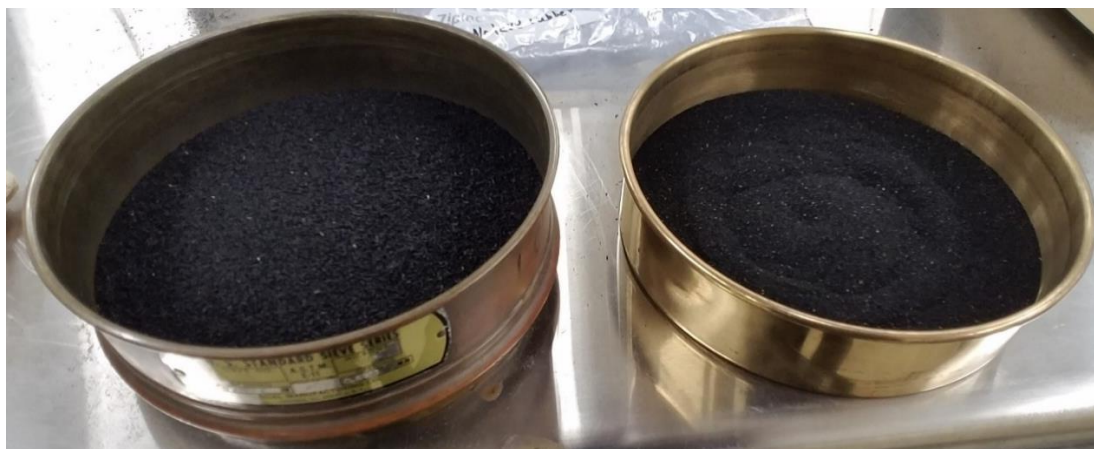
Figure 5: Two size classes of passenger tire crumb rubber were selected as greater than 0.5 mm (large, on left) and less than 0.5 mm (small, on right).

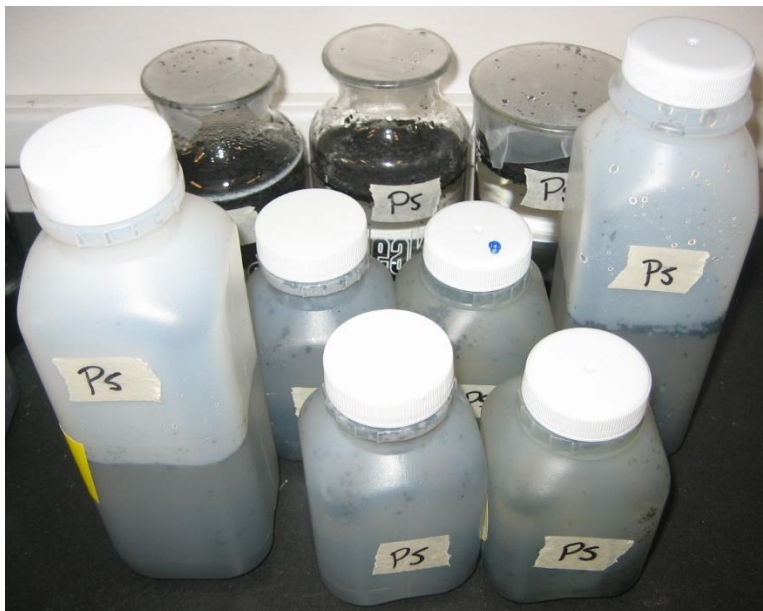
Figure 6: The small passenger crumb rubber batch leach test samples.

A crumb rubber leaching study was designed using the passenger and truck crumb rubber. Forty samples were created by taking each size class (small and large) for each of the two types of rubber and creating 10 duplicate samples of each class. This resulted in ten small passenger tire samples (PS), ten large passenger tire samples (PL), ten small truck tire samples (TS), and ten large truck tire samples (TL). Each sample consisted of three grams of tire, submerged in 240 milliliters of distilled water and placed in small bottles (Figures 6 and 7).

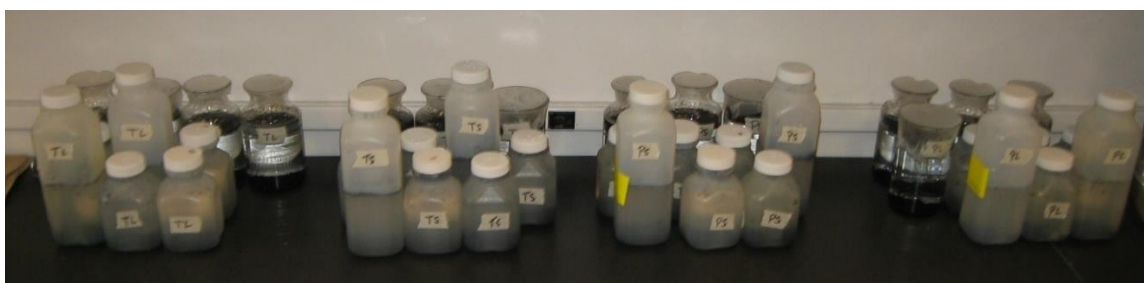
Figure 7: Forty batch leaching samples, each consisting of three grams of crumb rubber submerged in 240 milliliters of deionized water.

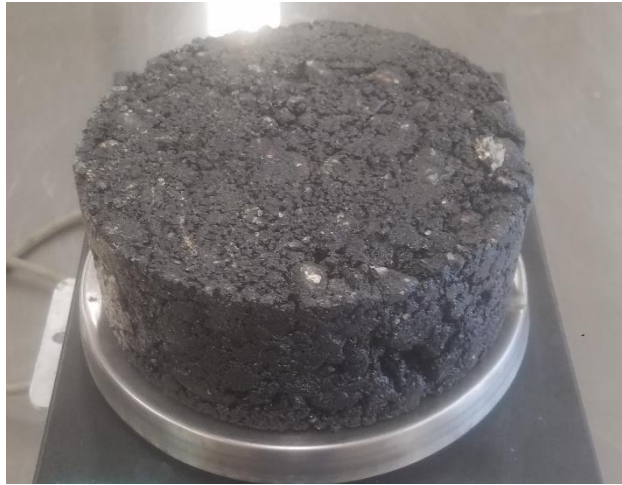
Figure 8: A representative pavement core used in the pavement core batch leaching test.

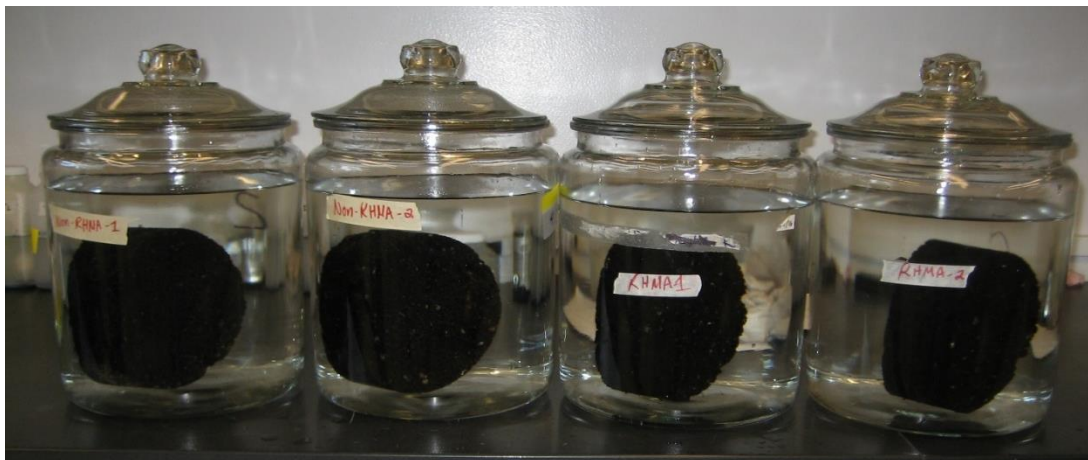
Figure 9: Four pavement cores placed in deionized water to assess the difference in zinc leaching from rubberized pavement in comparison to conventional pavement.

Each core was placed into a covered glass jar that contained seven liters of deionized water (Figure 9). Samples were taken after two and four days to assess the initial leaching rate and subsequent samples taken were spaced sufficiently far apart to capture the rate of change of leaching. After the varying time intervals, a 50 ml graduated cylinder was rinsed twice with deionized water and then used to extract 100 ml of water from each pavement bath. The contents of the jars were gently stirred prior to taking a leachate sample to mix any stratification of leached metals. Each sample was preserved in nitric acid and submitted to the laboratory for assessment of dissolved zinc content.

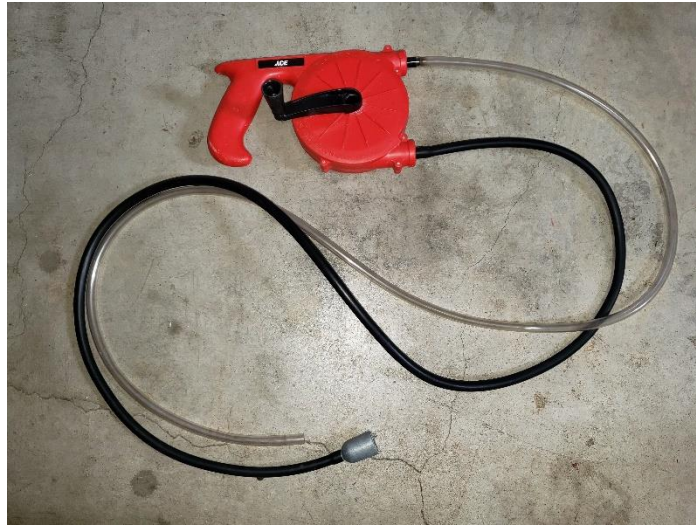
Figure 12: The rotary hand pump used to collect stormwater samples from pavement. Generally, the sample collection process would take no more than two hours, after which the samples to be analyzed for dissolved zinc were filtered using a 1.5-micron glass microfiber filter and preserved using nitric acid, while the total zinc samples were preserved without filtration. Some of the water was used to test the pH of the samples and all samples were submitted to a laboratory for analysis of total and dissolved zinc.

At the selected locations, samples were collected during storms that provided sufficient roadway runoff. The samples were collected on the edge of the pavement and attention was paid to avoid collection sites in proximity to soils or metals. Samples were collected from the pavement with a rotary hand pump and bottled on-site (Figure 12).

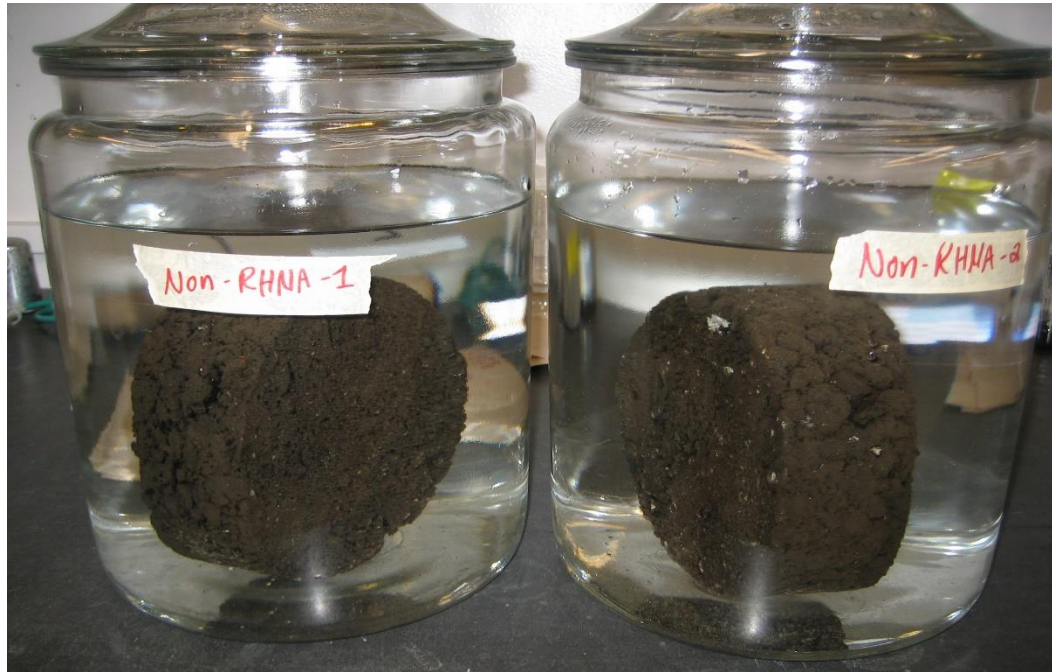
Figure 16: At the end of the leaching study, the HMA samples had turned brown in color, representing oxidation.

There was a notable difference in color between the RHMA and HMA samples after 61 days (RHMA) and 41 days (HMA) of leaching (Figure 16 and Figure 17). While

both types of pavement started off black, by day 41 the HMA sample has a brown color. Brown coloring is likely the result of oxidation, one of the primary causes of pavement wear that leads to a stiffer and brittle pavement. This result highlights the ability of the RHMA to withstand wear and resist degradation compared to the HMA.
