WARM SPRINGS NATIONAL FISH HATCHERY INTAKE IMPROVEMENTS

A Project Presented to

Master of Science in Environmental Systems: Environmental Resources Engineering

December 2016

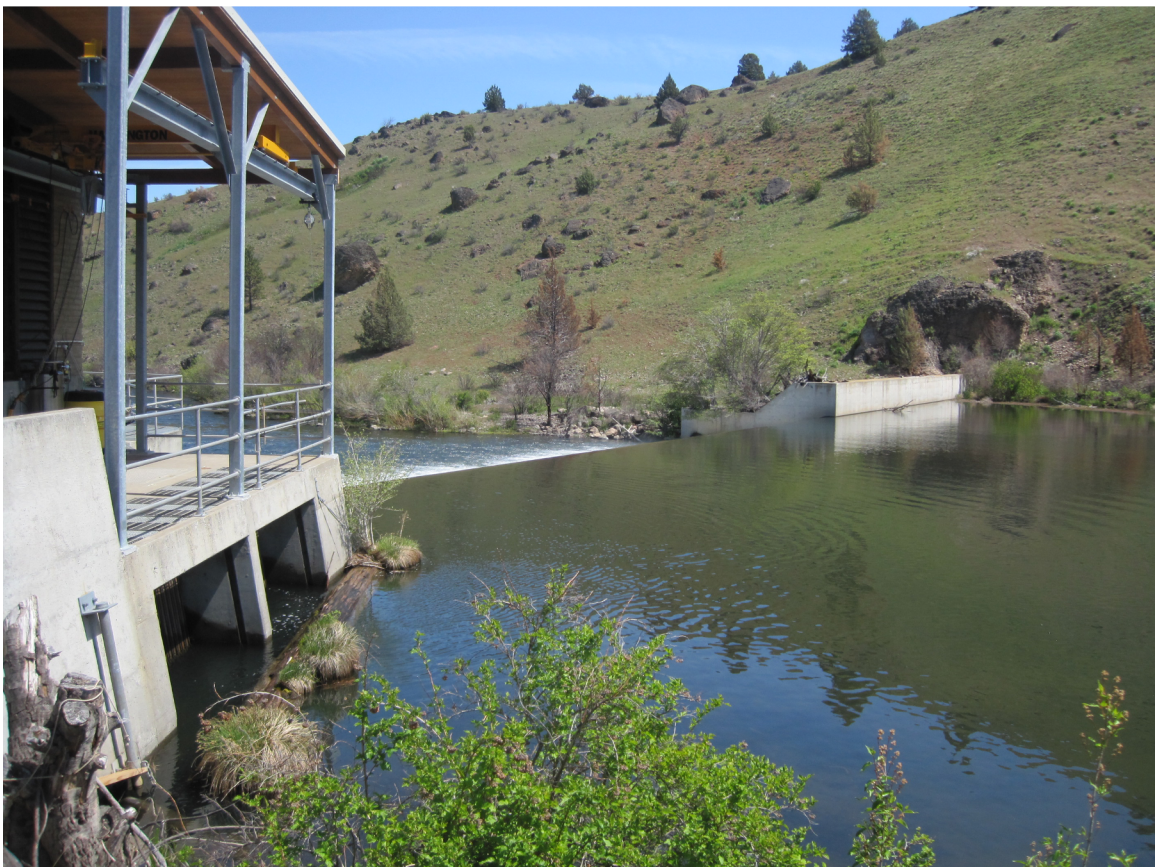
Figure 2. Existing hatchery intake, looking downstream towards weir.

Poor stream channel conditions just above the intake, due to heavy sediment deposition, has impacted the quality of the water entering into the hatchery. This has led to the hatchery experiencing high turbidity and extreme temperature variations in their

water throughout the year. This also negatively impacts the operations of the two hatchery intake fish screens and other components in the hatchery such as the sand filters and their ultraviolet disinfection system. The existing fish screens are both stainless steel Johnson fixed rotary drum screens that are 54 inches in diameter and 8 feet in length. The screens use a compressed air burst system to clean the debris off the screens. The fish screens were installed at Warm Springs NFH in the winter of 2004-05. They have not performed well and have been severely damaged several times primarily due to icing conditions in the forebays where the screens are located (SOW, 2014).

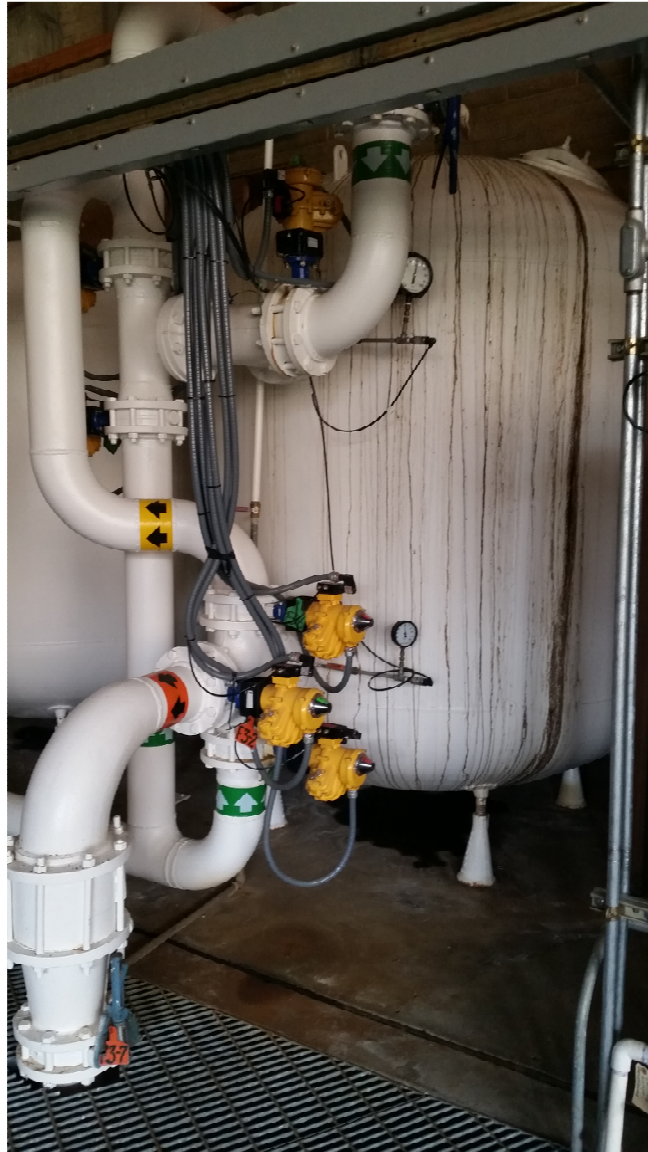
Figure 3. Existing sand filter, one of three.

Hatchery staff has expressed concern about the effectiveness of three existing sand filters that provide pre-treatment prior to ultraviolet (UV) disinfection. UV disinfection is utilized at the hatchery to eliminate the risk of pathogens infecting the brood stock. UV disinfection uses UV light to disinfect water by disrupting the DNA in cells. When DNA absorbs too much UV light, it becomes damaged and unable to replicate. The major factor affecting the performance of UV disinfection is water quality,

namely turbidity and suspended solids. Particles suspended in the water column can scatter the UV light reducing the effectiveness of disinfection.
