Volume 1 *ideaFest: Interdisciplinary Journal of Creative Works and Research from Humboldt State University*

Sedimentation Risk Assessment Using Satellite and Geospatial Data in Lagoa Feia, Brazil

Ualas B. Rohrer
Humboldt State University

Buddhika D. Madurapperuma
Humboldt State University

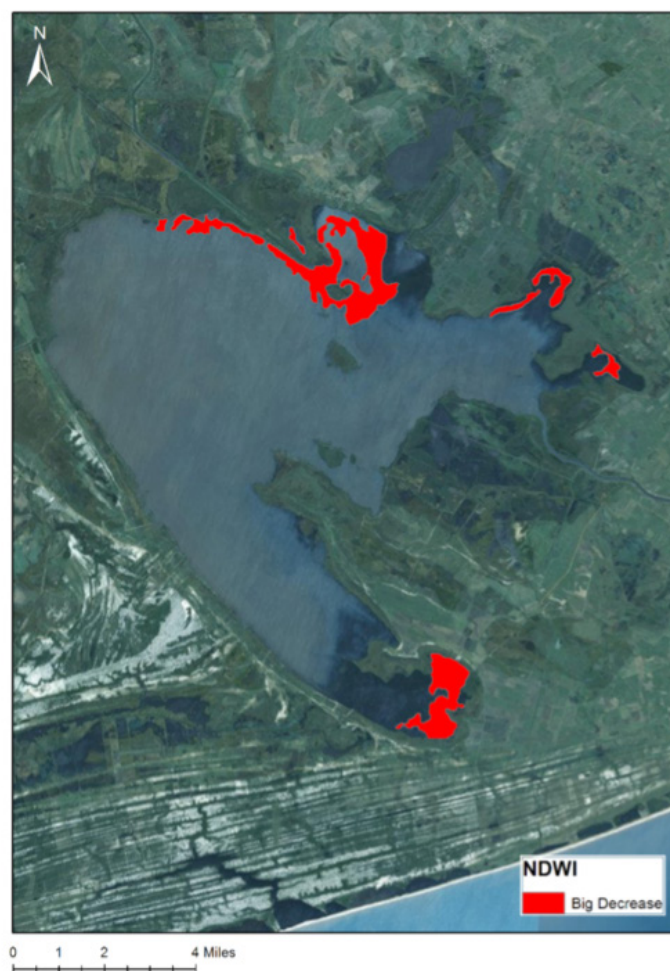
Figure 5: NDWI difference of Lagoa Feia between 2013 and 2016

It is possible to observe that areas near the edges of the lake experienced a decrease of the NDWI (Table 8).

Almost 3% of the lake area experienced a decrease of the NDWI, while no other area of the lake experienced an increase (Table 8 & Fig. 6).

By analyzing the NDWI difference map, it is possible to identify that experienced a significant decrease in the Normalized Difference Water Index. If the NDWI is lower, one can assume that the water has suffered interference of either vegetation or soil. Over these three years, the NDWI decreased at an area of 11.835 km², which is almost 3% of the total area of the lake.
