COMPREHENSIVE CONDITION SURVEY

✓
Inner Breakwater and the Sand Barrier
Crescent City Harbor
Del Norte County, California

COMPREHENSIVE CONDITION SURVEY OF
CRESCENT CITY HARBOR INNER BRAKWATER AND
SAND BARRIER

Prepared by
U.S. Army Corps of Engineers
Los Angeles District

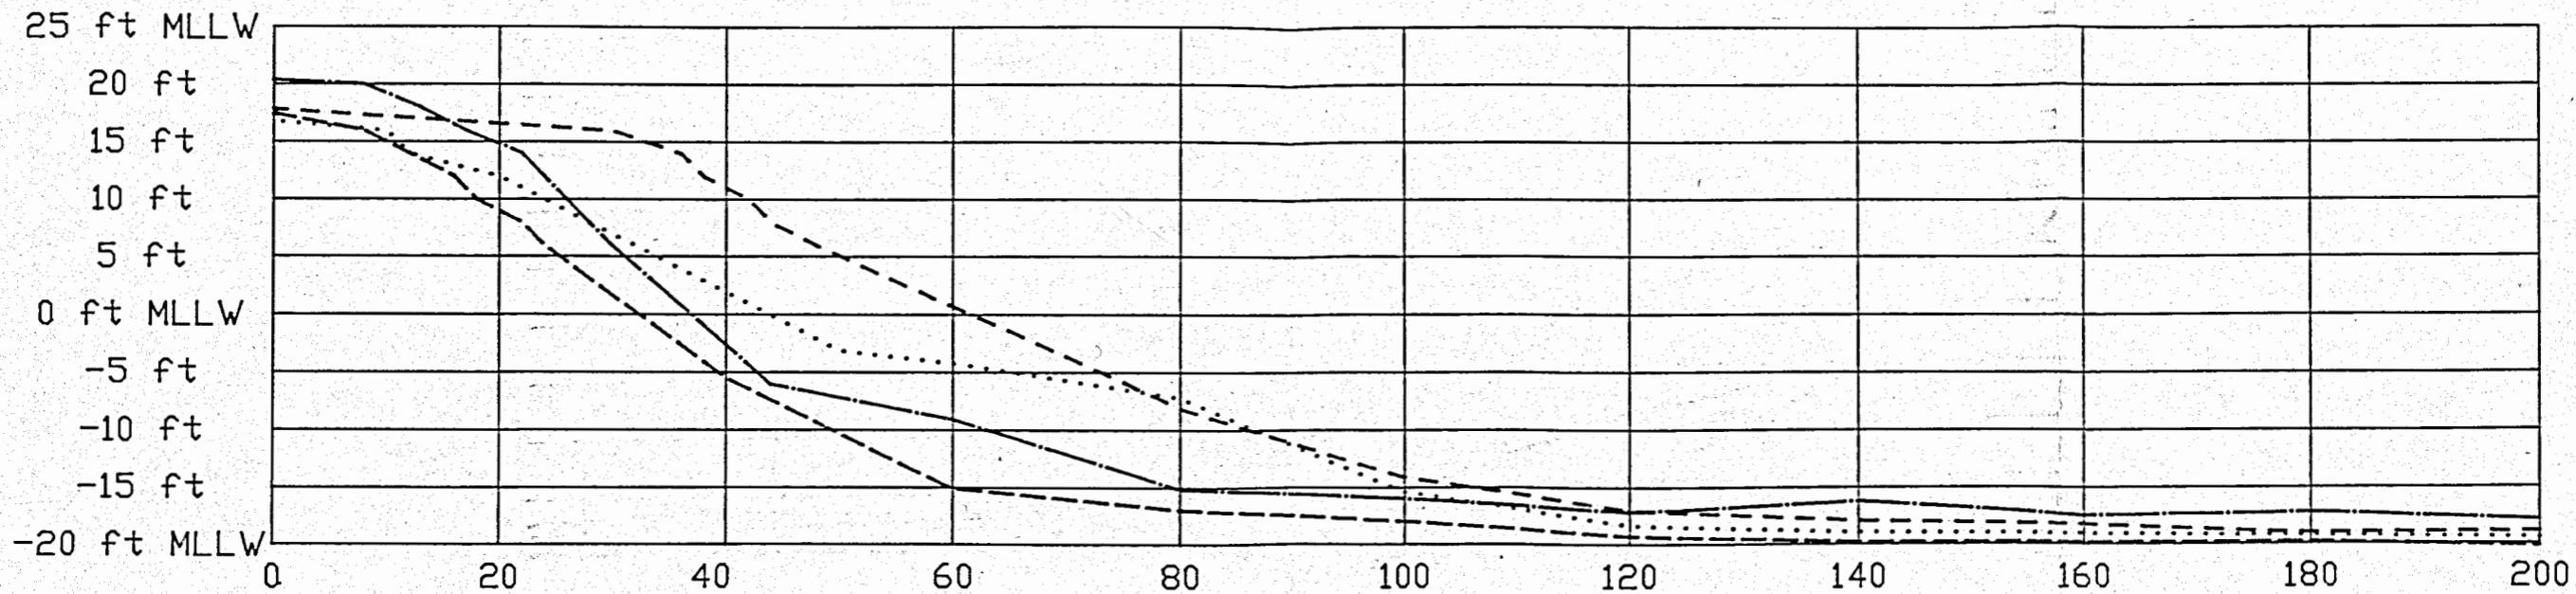
FIGURE 7

Station 3+00 (Point 1) ——— Station 7+04 (Point 2) - - - - -
 Station 11+00 (Point 3) - - - - - Station 14+82 (Point 4) ·····

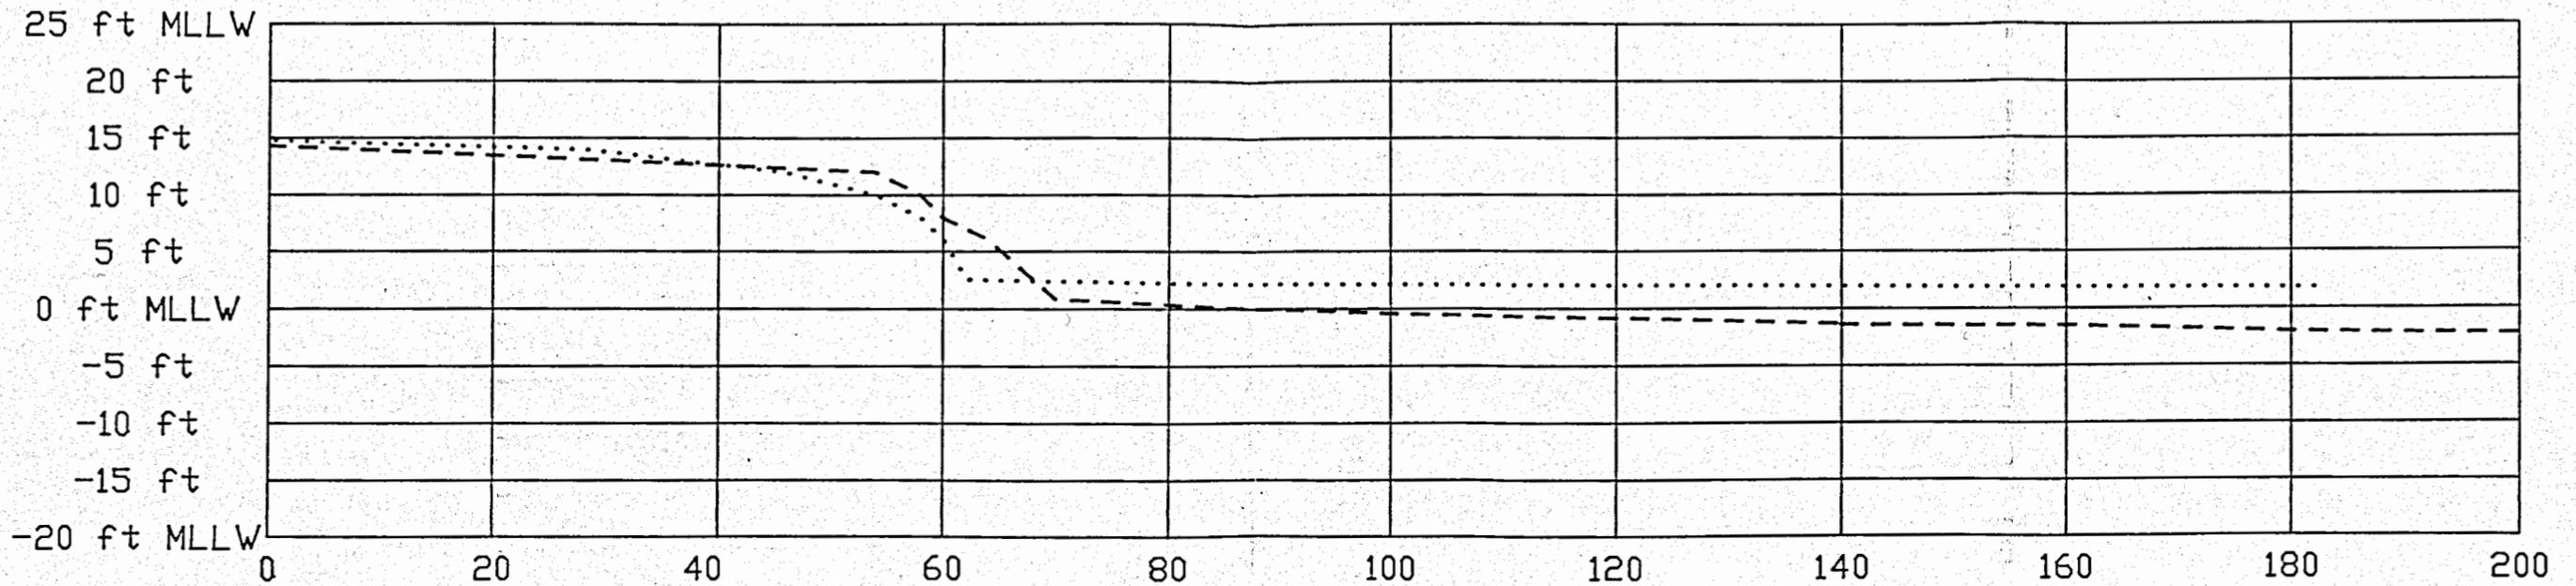
FIGURE 8

Origin of Profile 17+00 is Monument SB17

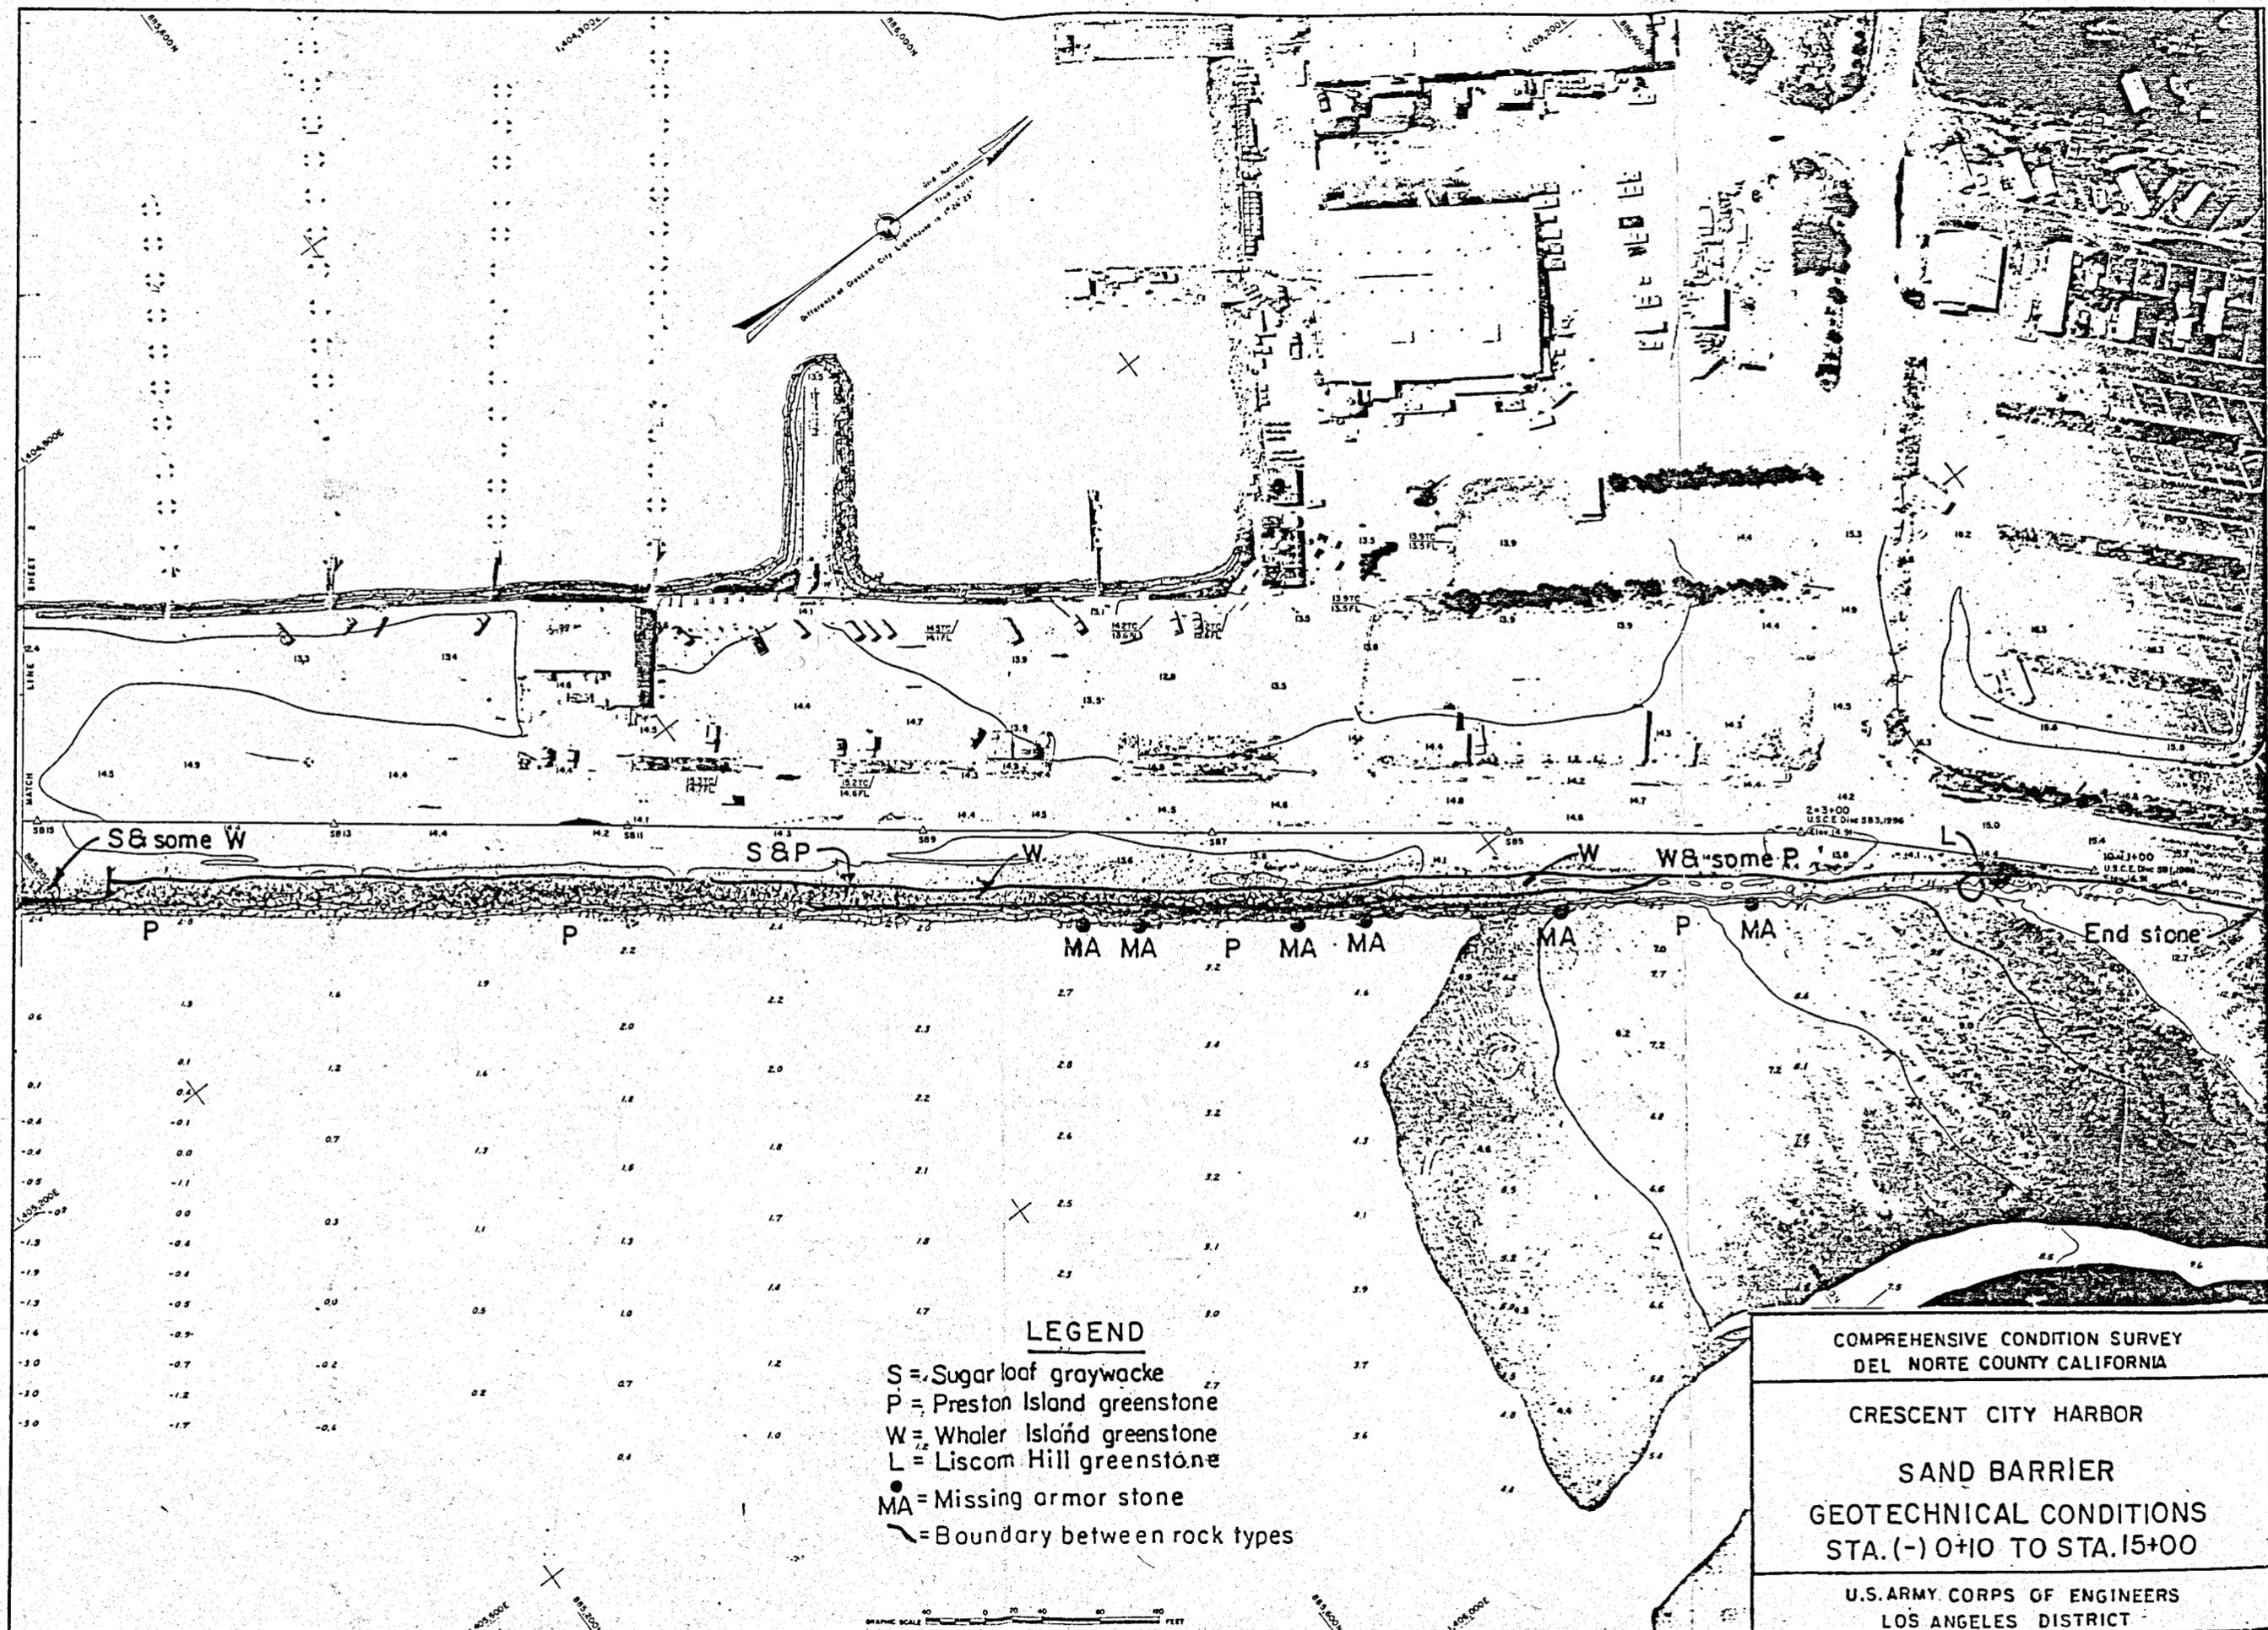
GEOTECHNICAL CONDITIONS
 STA. (-) 0+10 TO STA. 15+00

- S = Sugar loaf graywacke
- P = Preston Island greenstone
- W = Whaler Island greenstone
- L = Liscom Hill greenstone
- MA = Missing armor stone
- = Boundary between rock types

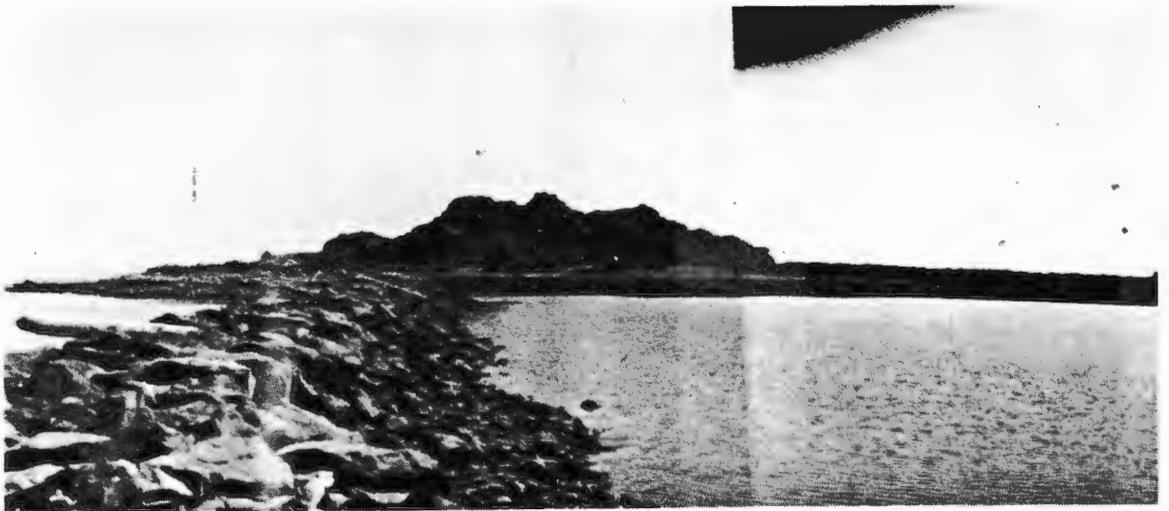
2. SAND BARRIER. The barrier from about the middle looking towards Whaler Island. Note smaller stone below about elevation +6 MLLW on the harbor slope and the irregularity of the slope. June 1970

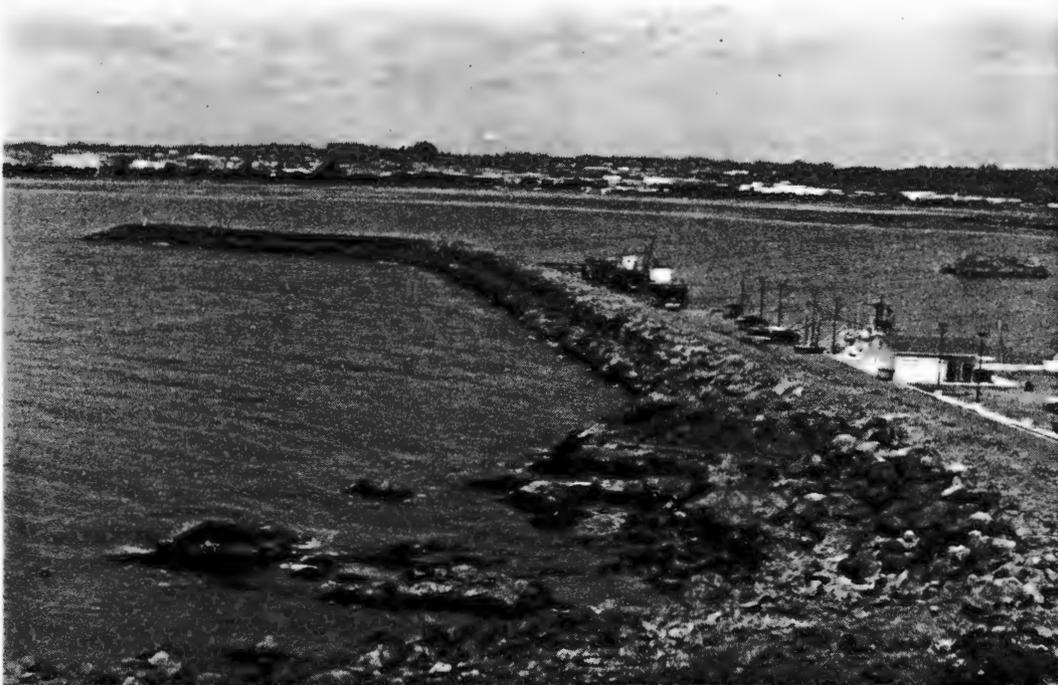
11. INNER BREAKWATER. Ocean side from Whaler Island. April 1986

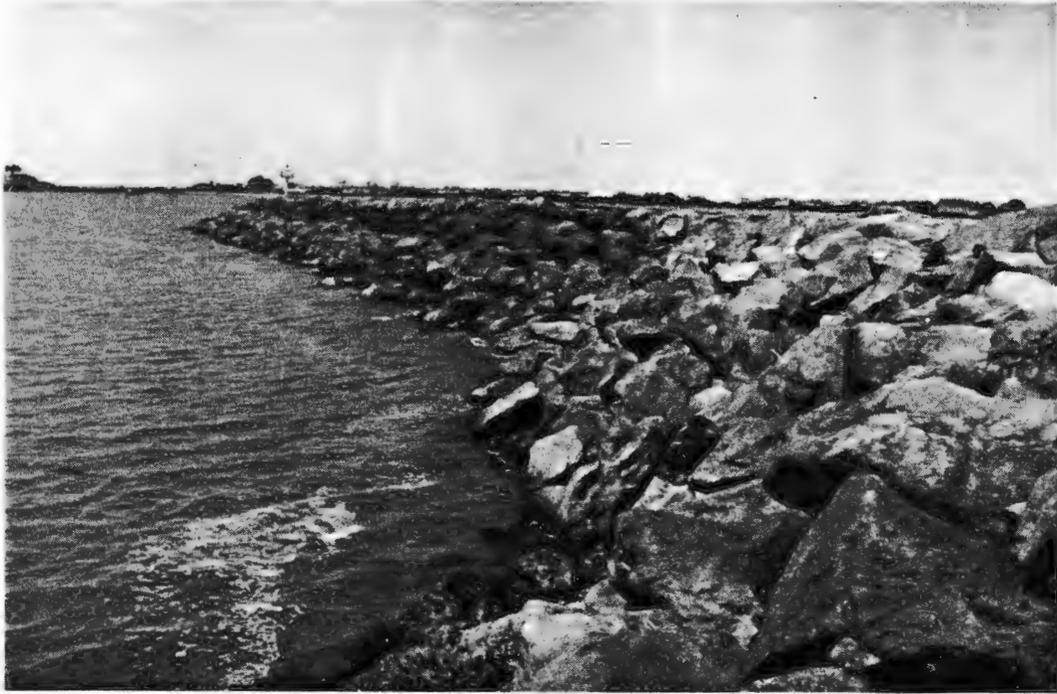
13. INNER BREAKWATER. Ocean slope up station from station 10+00. April 1986

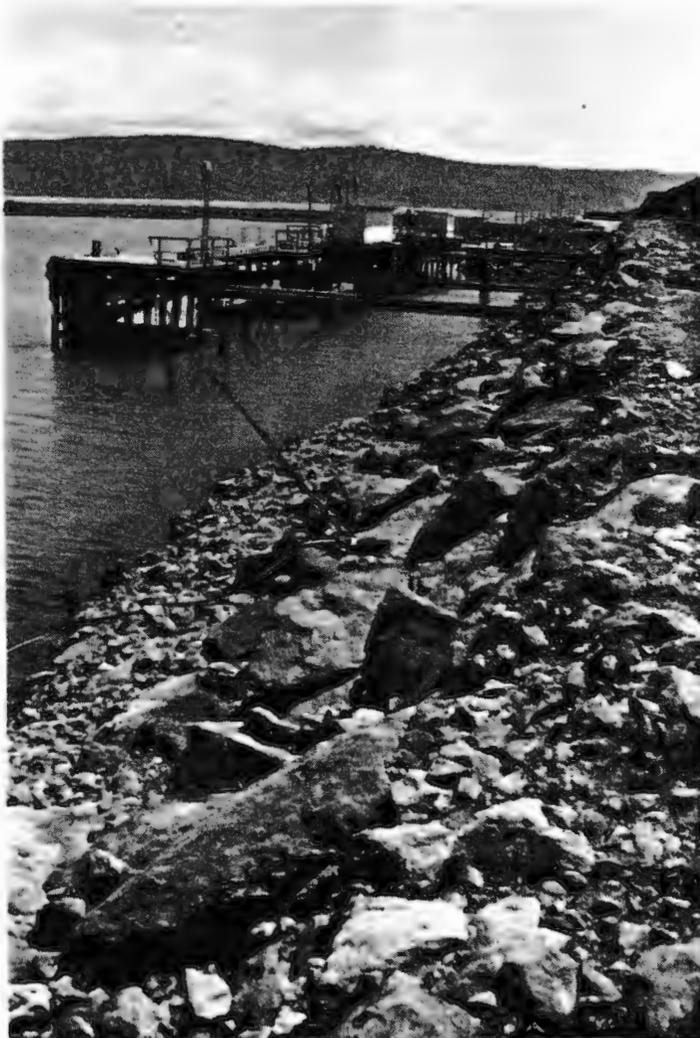
14. INNER BREAKWATER. Harbor slope down station from station 11+00. Note small stone "bench" near the water line. April 1986

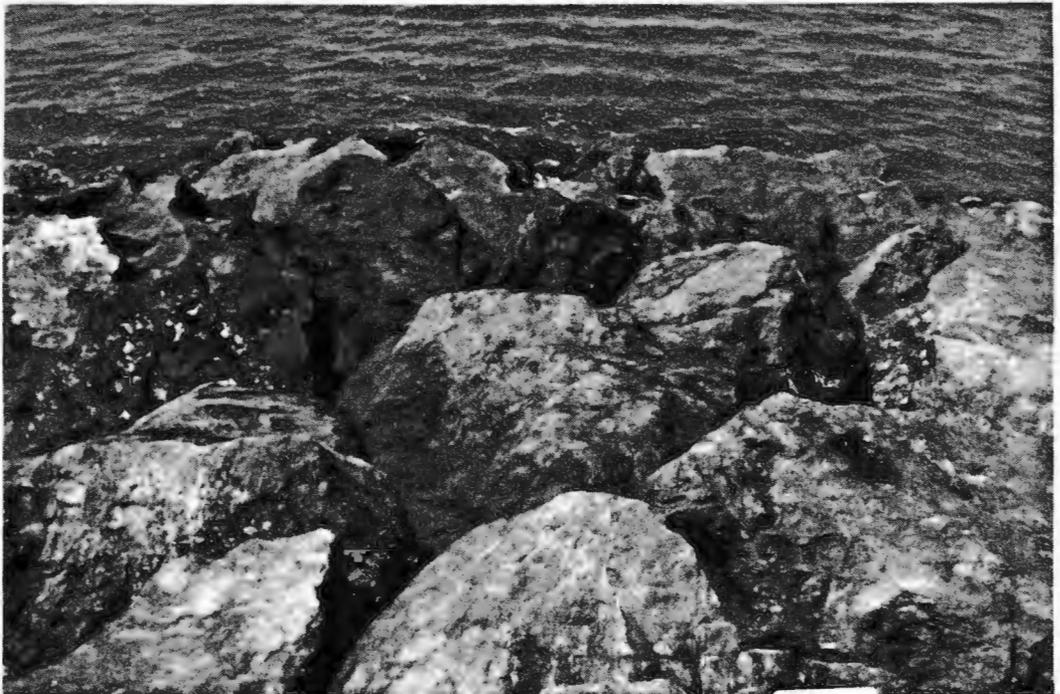
16. INNER BREAKWATER. Gardner Ridge gabbro on the center line of the head. April 1986
